# VOLUME 1 - REPORT

## JORDAN RIVER HYDRAULIC STUDY

July 2019

**BOWEN COLLINS**  
& ASSOCIATES

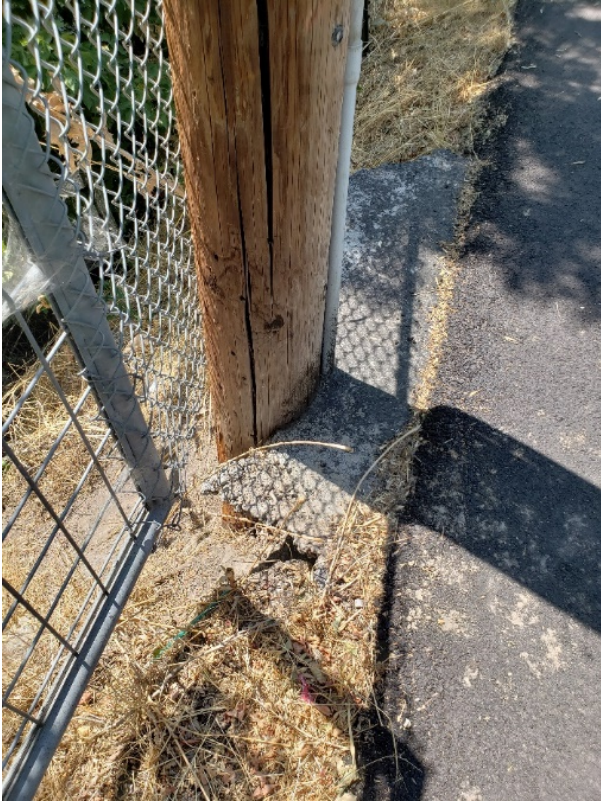
- **Bank Erosion.** River banks in some areas have experienced erosion and the bank slope is nearly vertical. In some areas, the vertical banks range from 5-10 feet in height. However, these vertical banks and the associated bank instability are not currently near development. The biggest current concerns associated with erosion are a power pole on the inside of the bank near 1300 South, as shown below in Photo 1, and the tall vertical bank where the river is cutting into a hill on the west bank just upstream of the 12600 South Bridge over the river (see Photo 2).

*Photo 1: Erosion near a power pole on inside of bank at approximately 1300 South*

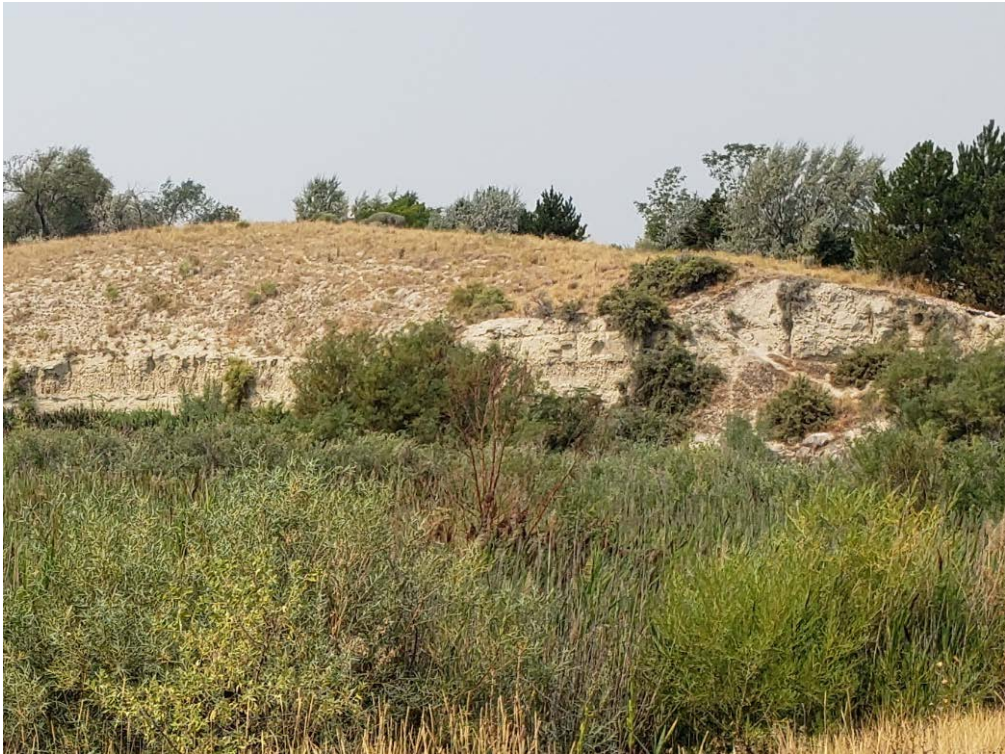
*Photo 2: Tall vertical bank just upstream of the bridge at 12600 South*

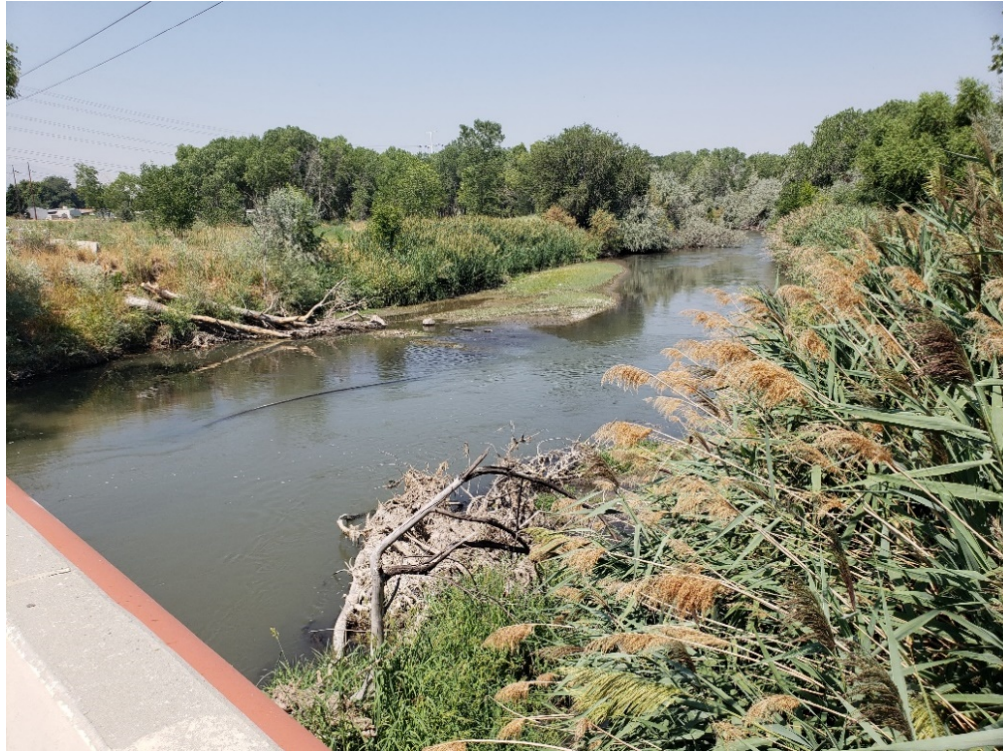
- Vegetation on River Banks.** Vegetation on the channel banks of the river throughout the study area contain dense vegetation that is well established. Much of the vegetation on the banks are invasive species (Russian Olive and Tamarisk) and there are more established trees on the banks of the Lower Jordan River than there are upstream of 2100 South. There are also intermittent trees, including some with exposed roots, or dead branches that are in or near the water (see Photo 3 below). It is believed that the bank vegetation upstream of 2100 south is generally denser than it was when the current effective model and floodplain were developed in the 1990s.

*Photo 3: Thick vegetation, fallen trees, and sediment bar at approximately 3900 South.*

- **Sedimentation.** Another potential problem that was a focus of the field reconnaissance was to identify areas where sediment deposition could increase flood or erosion potential. Sedimentation problems are common near tributary confluences and near irrigation diversions. The only location where significant sediment deposition has occurred is in the tailwater area immediately upstream of the Joint Diversion Structure (see Photo 7 below). Since there is not development near this area, this problem is not a major concern. It is also recommended that the County continue to monitor and remove sediment deposits between 3700 South and 4200 South (see Photo 3 above).

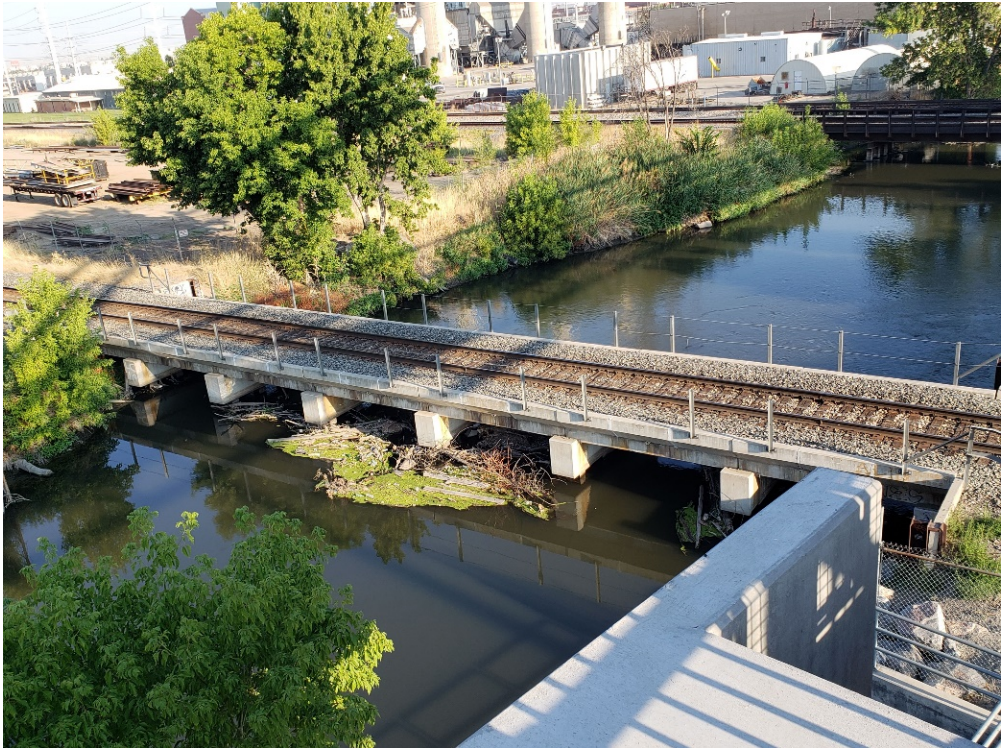
- Potential for Debris Plugging.** Although most of the bridges and hydraulic structures in the study reach are wide and designed to provide freeboard during a 100-year flood, some structures have piers that could potentially collect debris and restrict flow in the river. This is especially true on the Lower Jordan River where there are several railroad crossings and other structures with multiple piers, as shown below in Photos 4 and 5. There is also an abandoned bridge structure with multiple piers at about 2700 North that should be removed to reduce the potential for flooding associated with debris plugging. (See Photo 6).

*Photo 4: Piers on railroad bridge at approximately 100 South could collect debris*

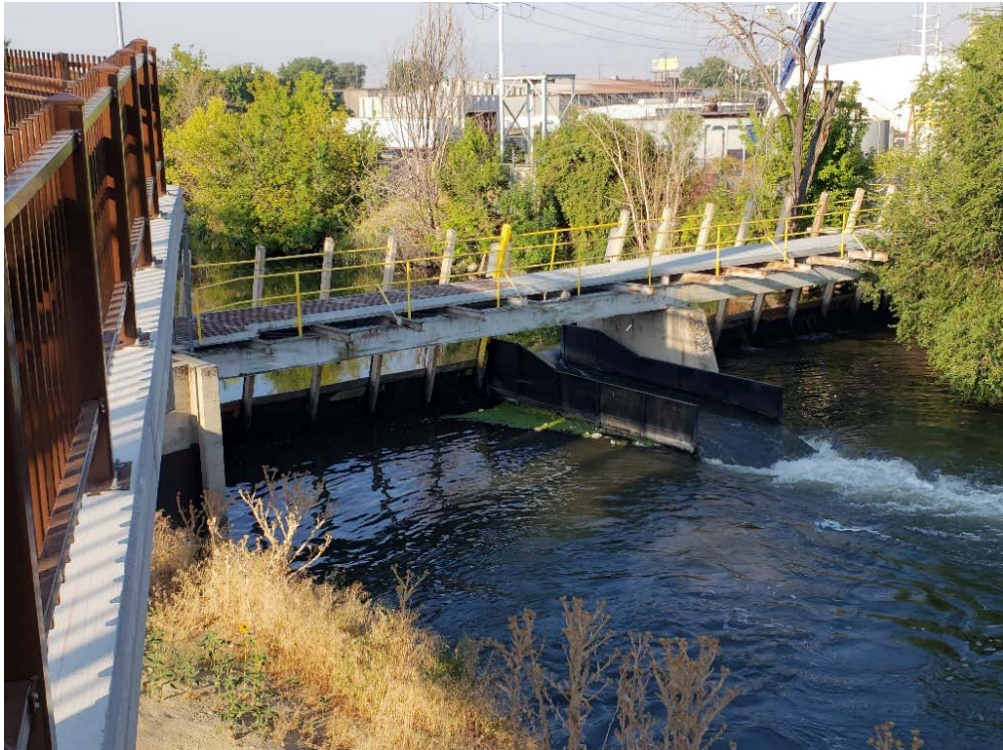
*Photo 5: A diversion structure with a canoe passage feature near South Temple has piers that could potentially capture debris*

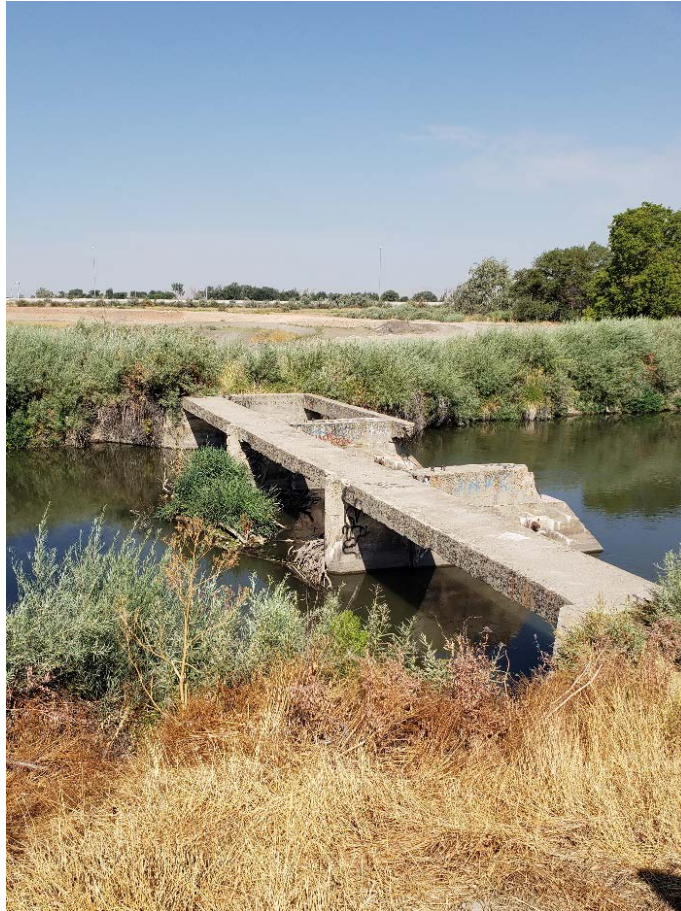
*Photo 6: Abandoned bridge structure at about 2700 North should be removed*

- 1. Remove the Abandoned Bridge Structure at 2700 North.** Remnants of an abandoned bridge that includes multiple piers is located at about 2700 North on the Lower Jordan River. This abandoned structure is prone to plug with floating debris during a large runoff event and is in a location that is difficult to monitor. This structure should be removed to mitigate the hazards associated with debris plugging. The estimated cost for this project is \$30,000.

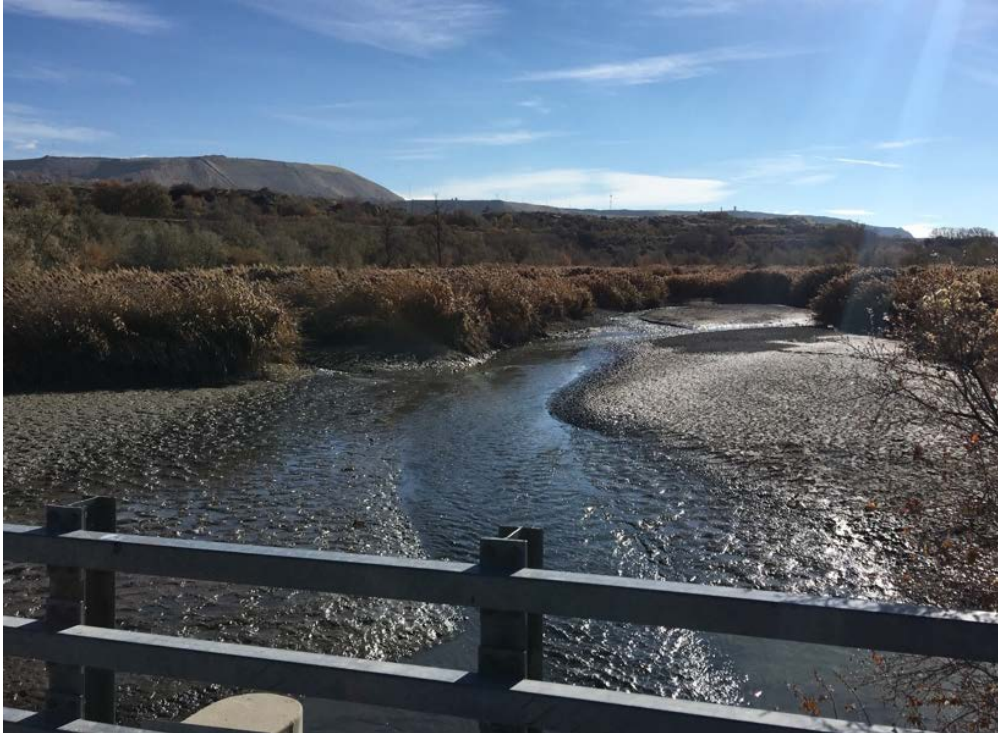
*Photo 7: Sediment deposition upstream of the Joint Diversion*

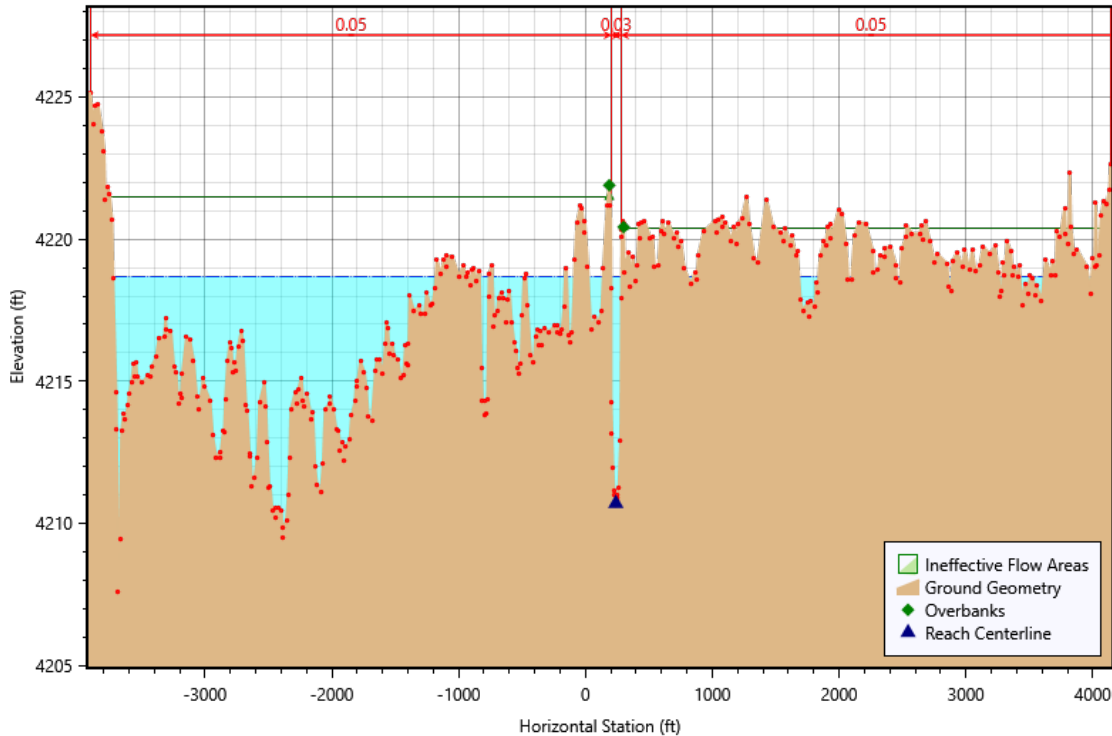
**Graphic 1**  
*Modeled Channel Cross Section Near 1100 North*

Graphic 1 contains an image of a channel cross section extracted from the HEC-RAS model. This particular cross section is near 1100 North and is approximately 1.5 miles wide. The model was set to make both overbanks ineffective flow areas, meaning it only calculates the water surface based on the flow area inside the main channel. However, the image demonstrates that the 100-year water surface in the channel is higher than almost the entire area in the left overbank, and

higher some of the roads in the right overbank. It should be noted that, depending on the flood duration and storm hydrograph, this may cause storm drain pipes to backup and result in local flooding, mostly in the streets, east of the river. Most of the area west of the Jordan River in Salt Lake City drains to other storm water management facilities.
