**VOLUME 3 - APPENDICES**  
**JORDAN RIVER**  
**HYDRAULIC STUDY**

July 2019

**BOWEN COLLINS**  
& ASSOCIATES

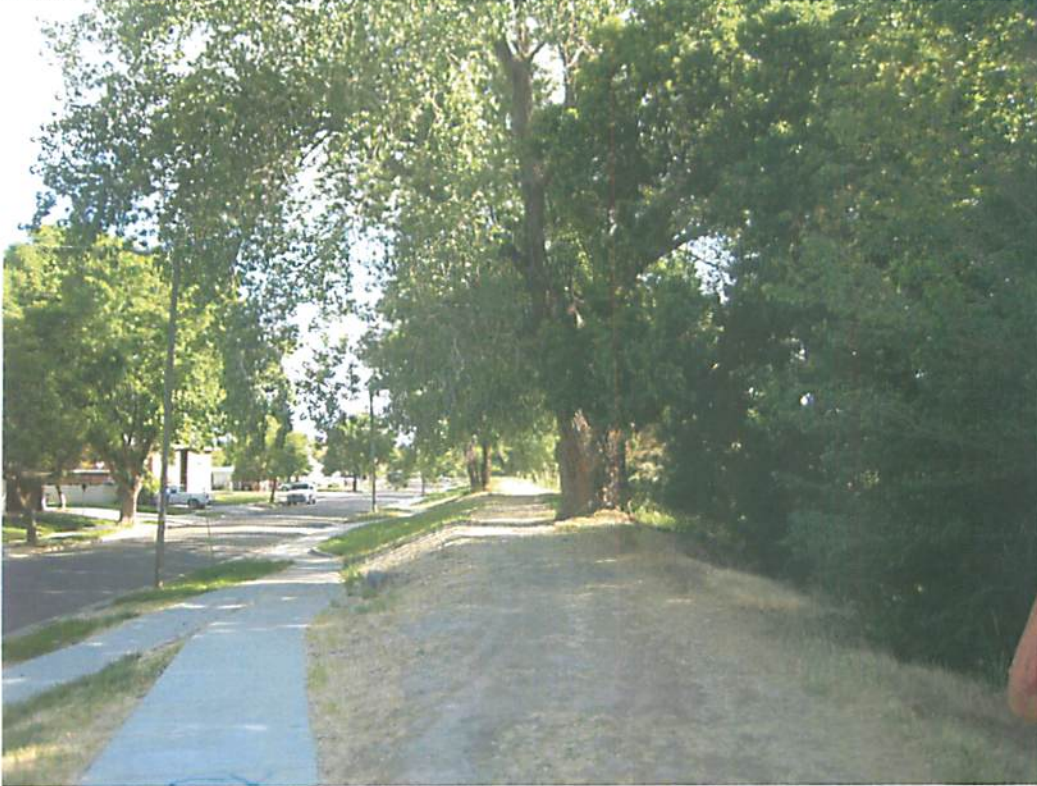
**PHOTO 8**  
Oversteepened Bank, Trees on the Levee (river on the left)

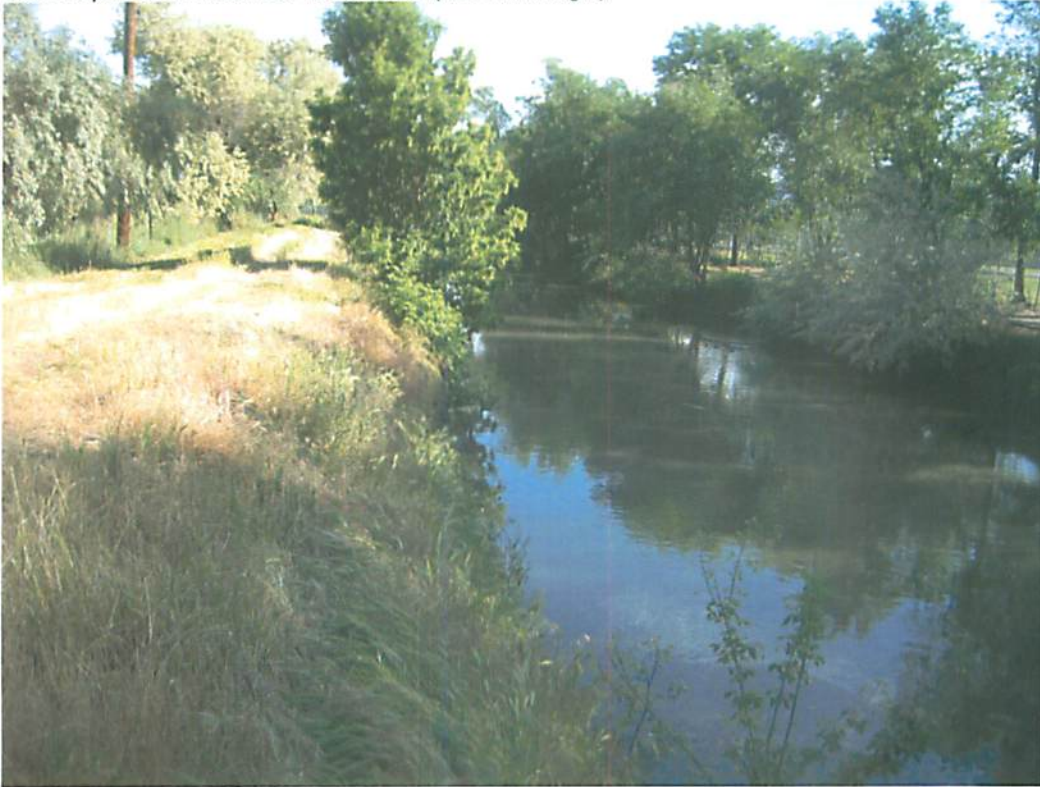
**PHOTO 15**  
Shallow Sloughing Failure or River Bank (river on the right)

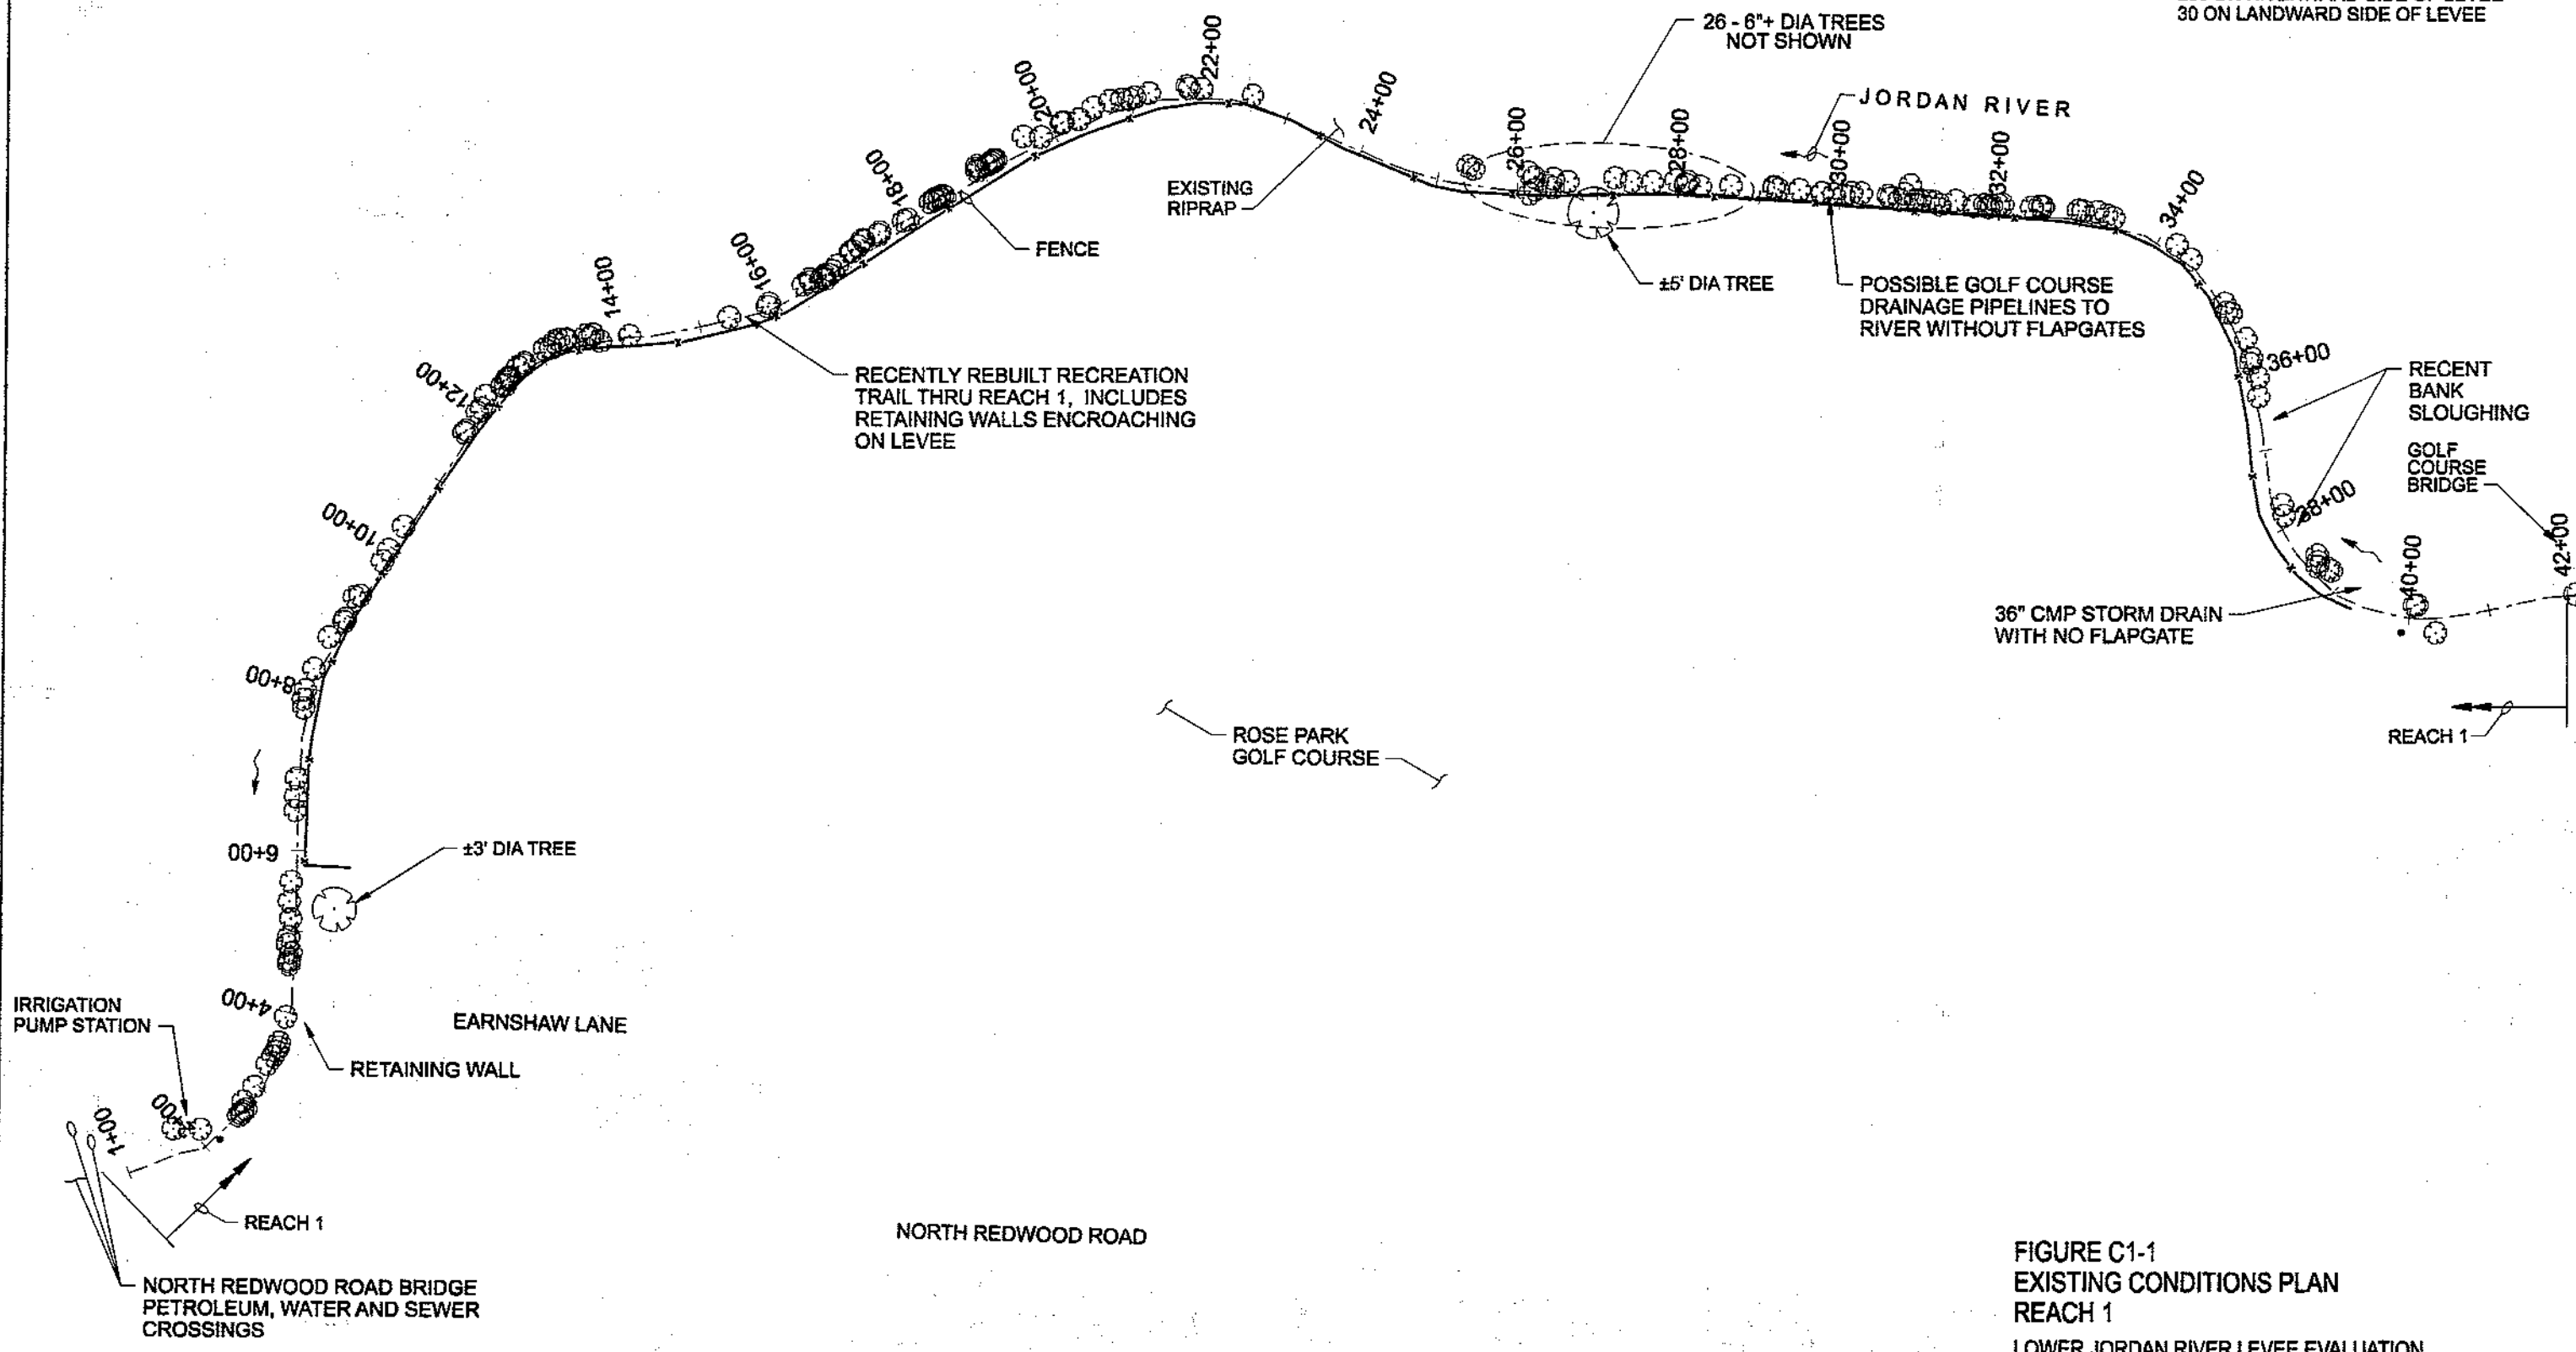
**FIGURE C1-1**  
**EXISTING CONDITIONS PLAN**  
**REACH 1**  
 LOWER JORDAN RIVER LEVEE EVALUATION  
 NOVEMBER 2009

**TOTAL TREES > 2"**  
 230 ON RIVERWARD SIDE OF LEVEE  
 30 ON LANDWARD SIDE OF LEVEE

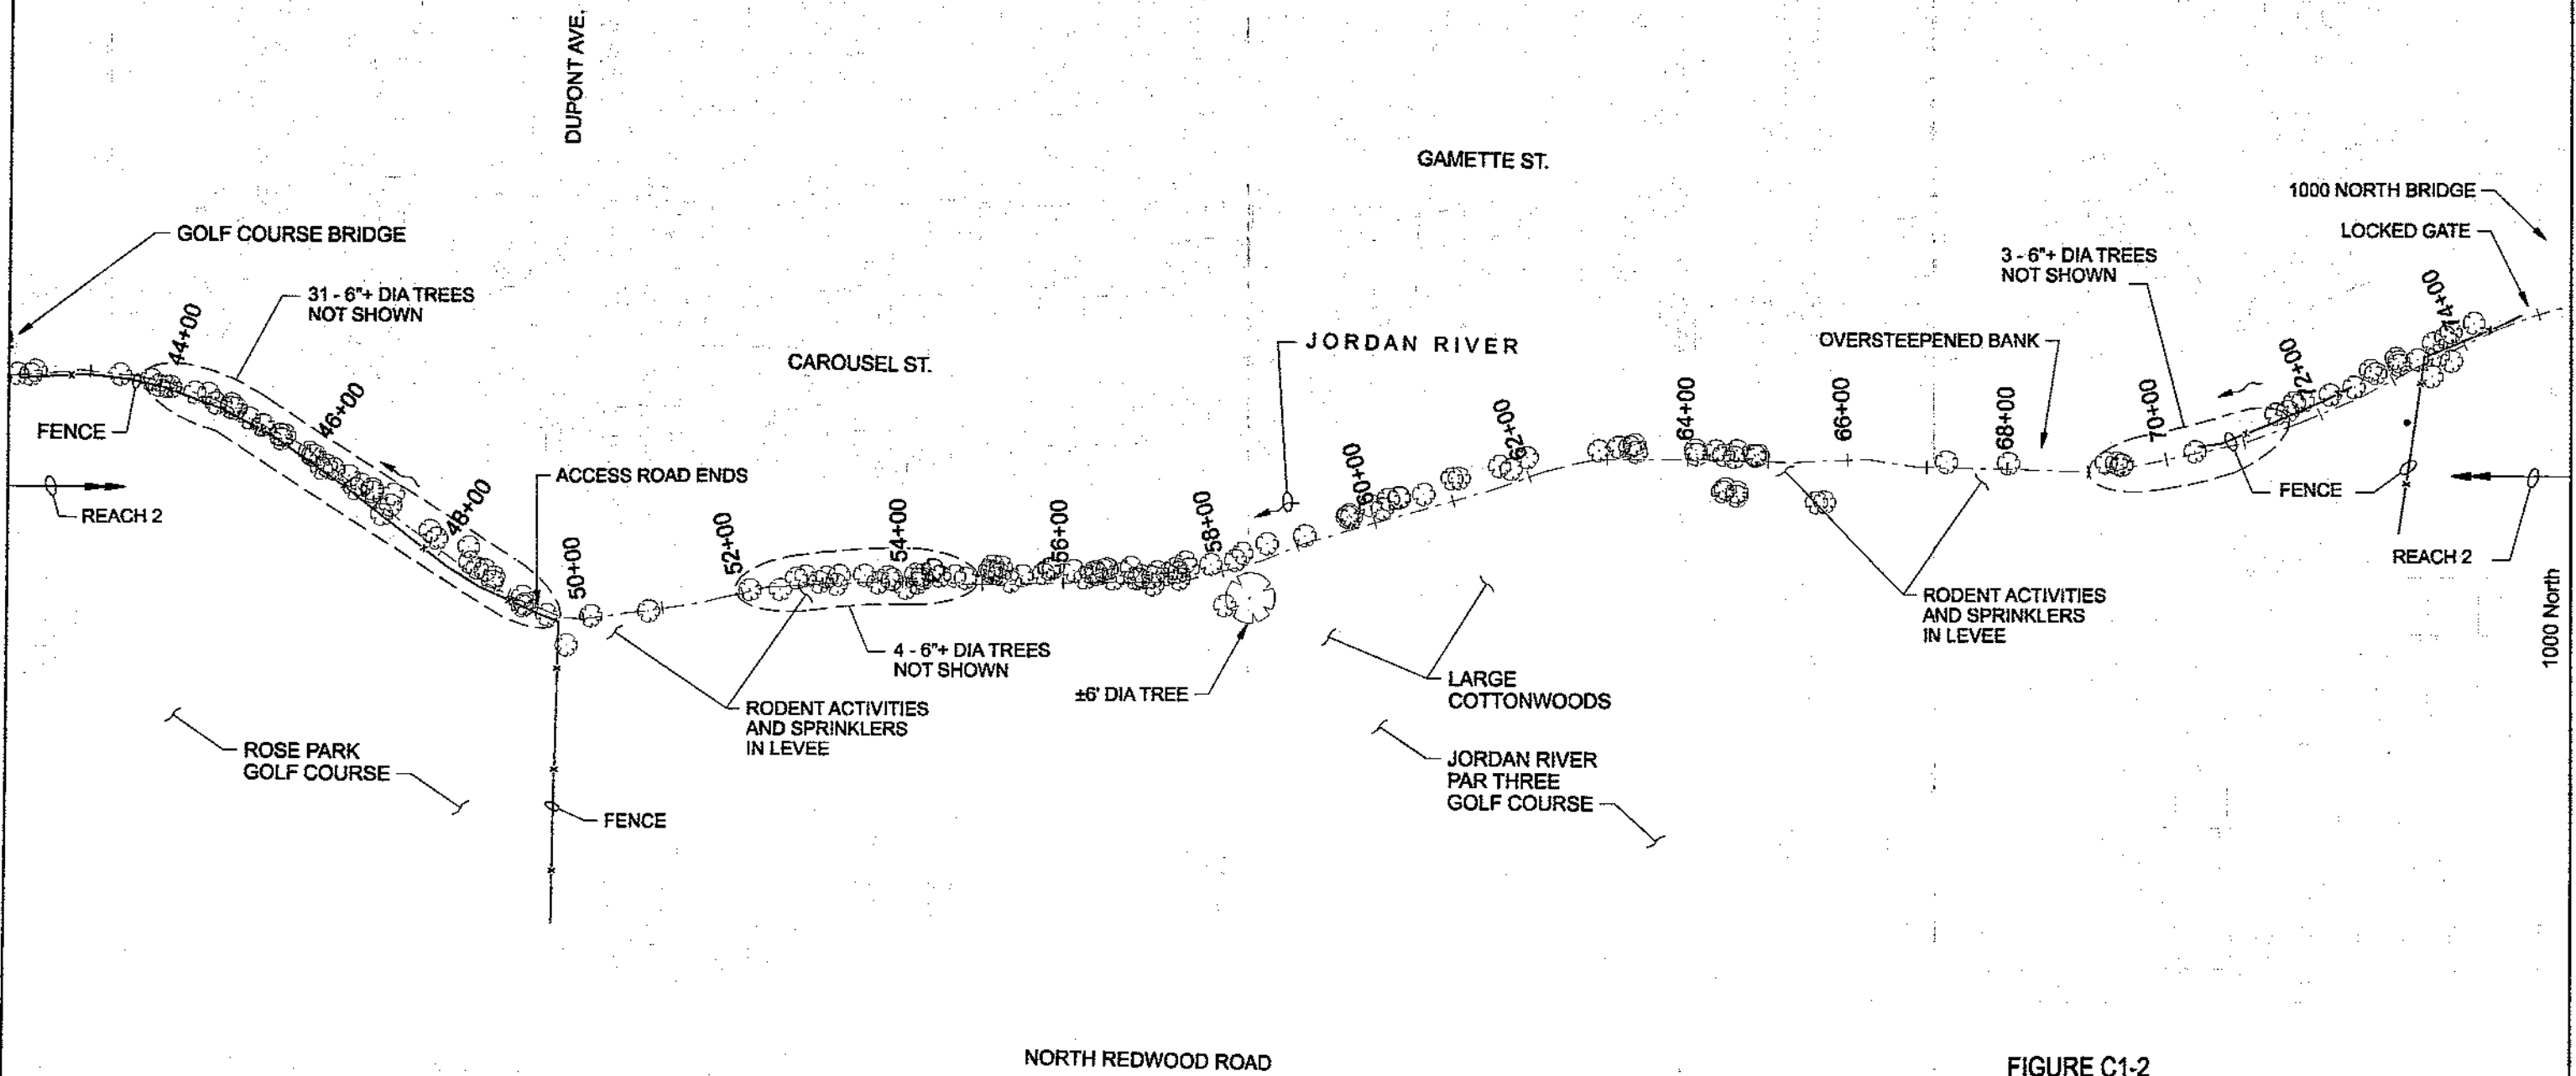
**FIGURE C1-2**  
**EXISTING CONDITIONS PLAN**  
**REACH 2**  
 LOWER JORDAN RIVER LEVEE EVALUATION  
 NOVEMBER 2009

**TOTAL TREES > 2"**  
 250 ON RIVERWARD SIDE OF LEVEE  
 30 ON LANDWARD SIDE OF LEVEE

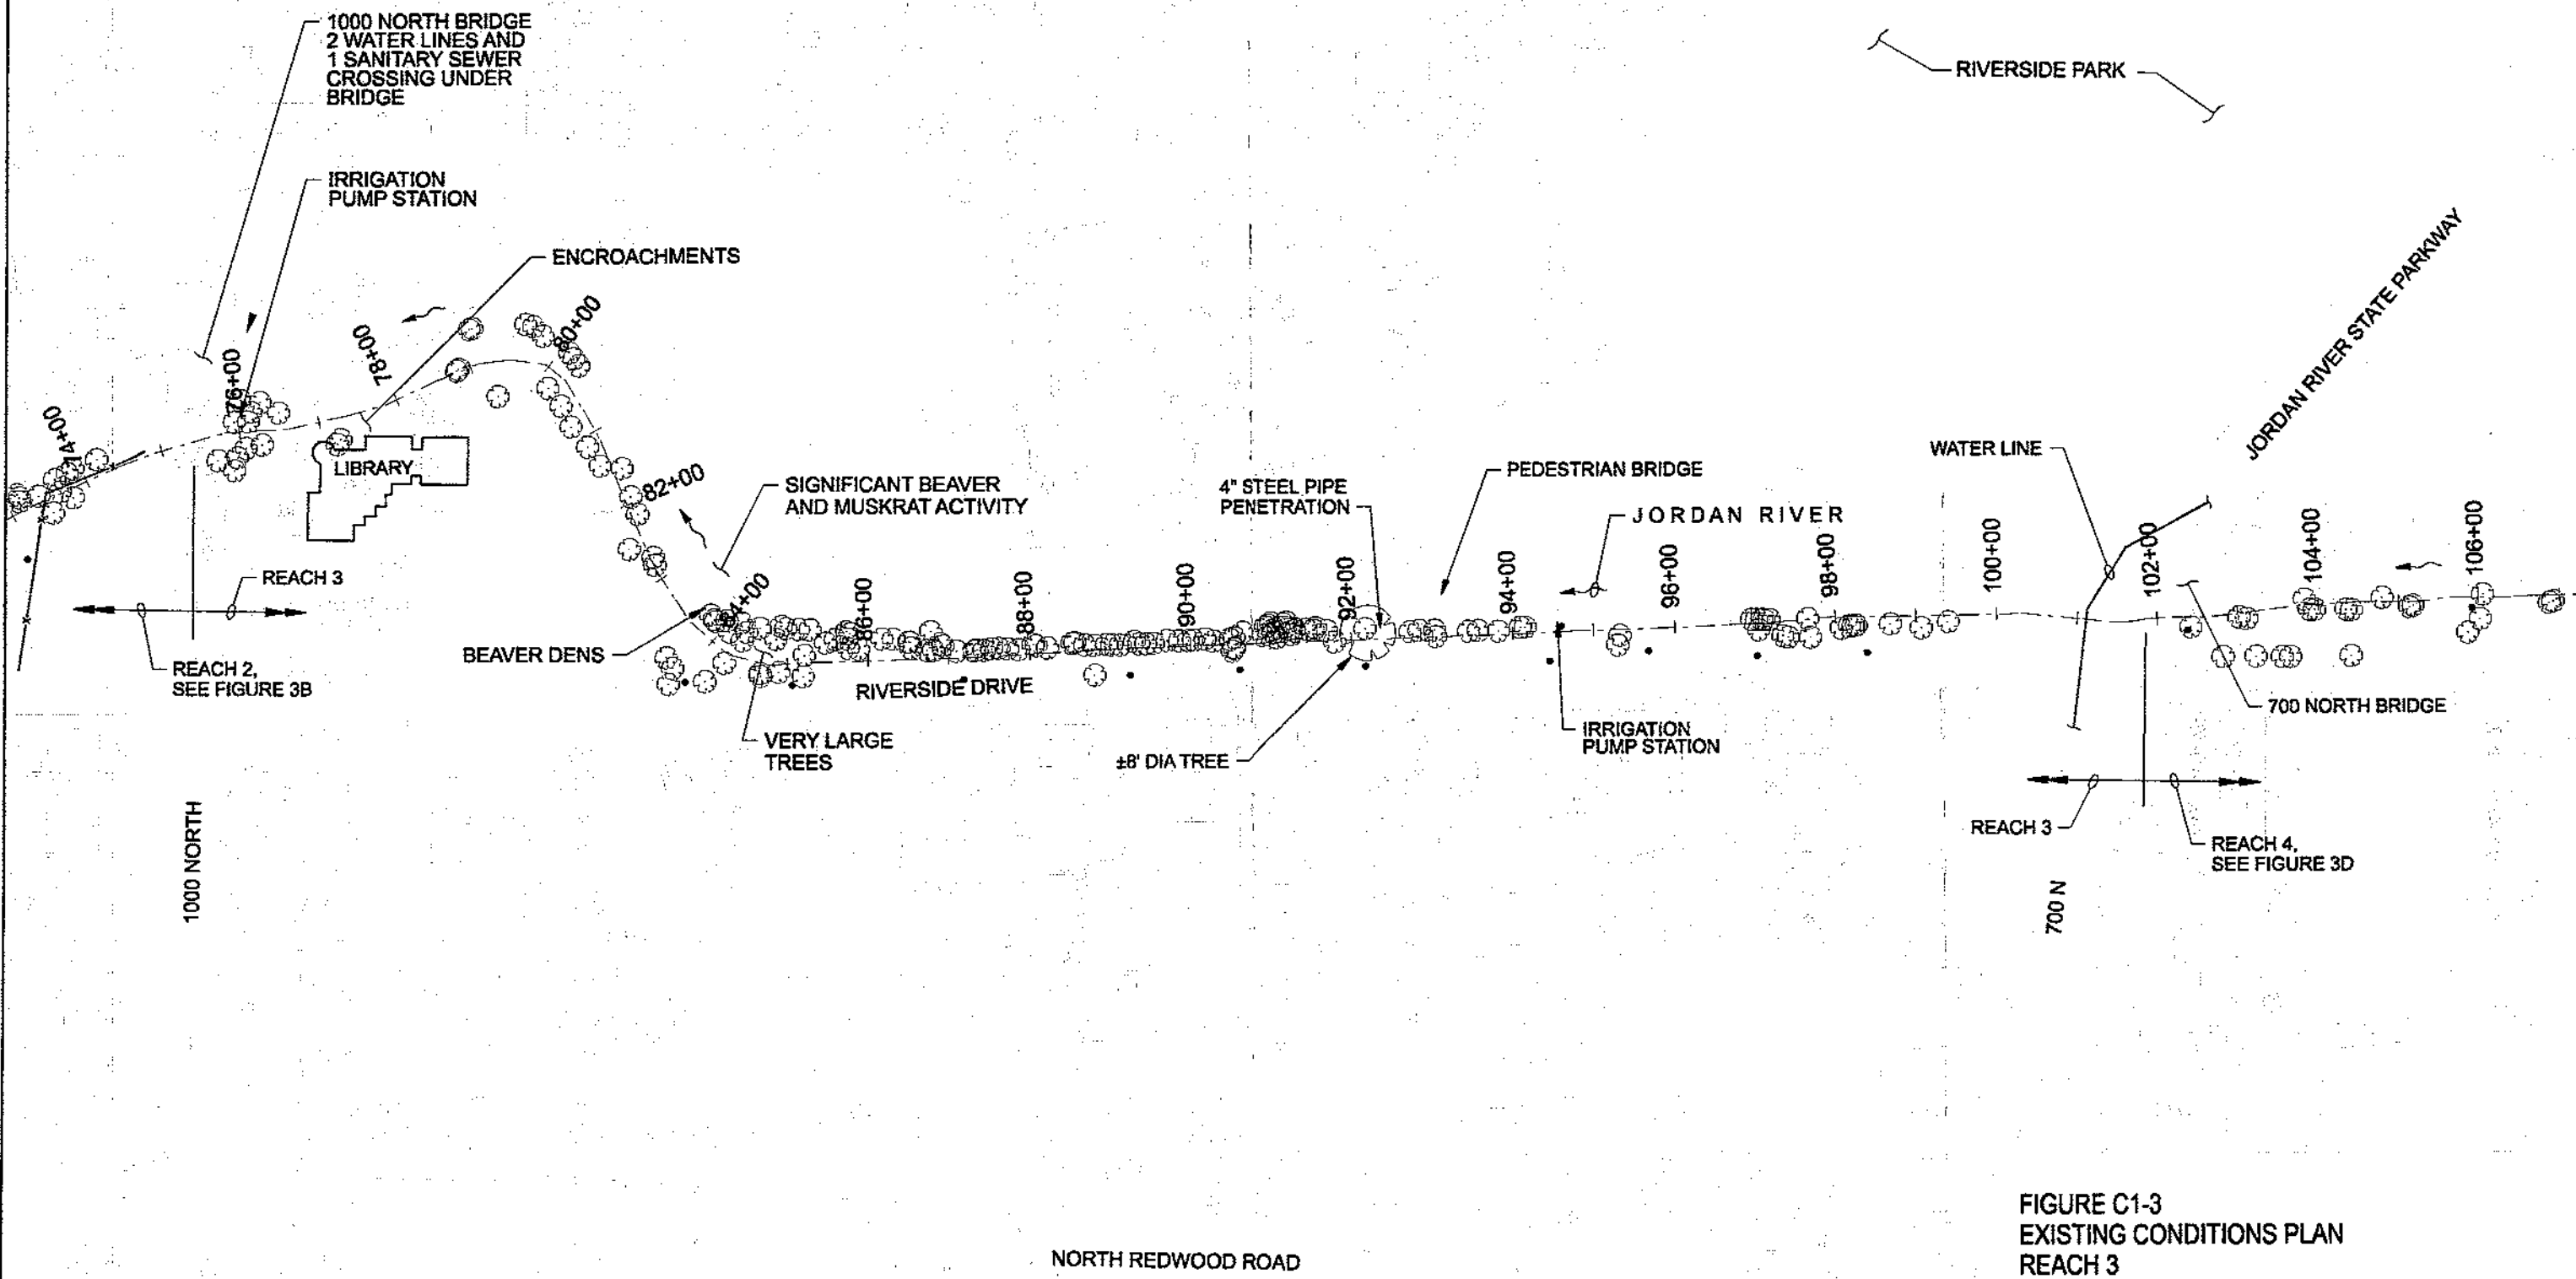
**FIGURE C1-3**  
**EXISTING CONDITIONS PLAN**  
**REACH 3**  
 LOWER JORDAN RIVER LEVEE EVALUATION  
 NOVEMBER 2009  
**CH2MHILL**

**TOTAL TREES > 2"**  
 100 ON RIVERWARD SIDE OF LEVEE  
 30 ON LANDWARD SIDE OF LEVEE

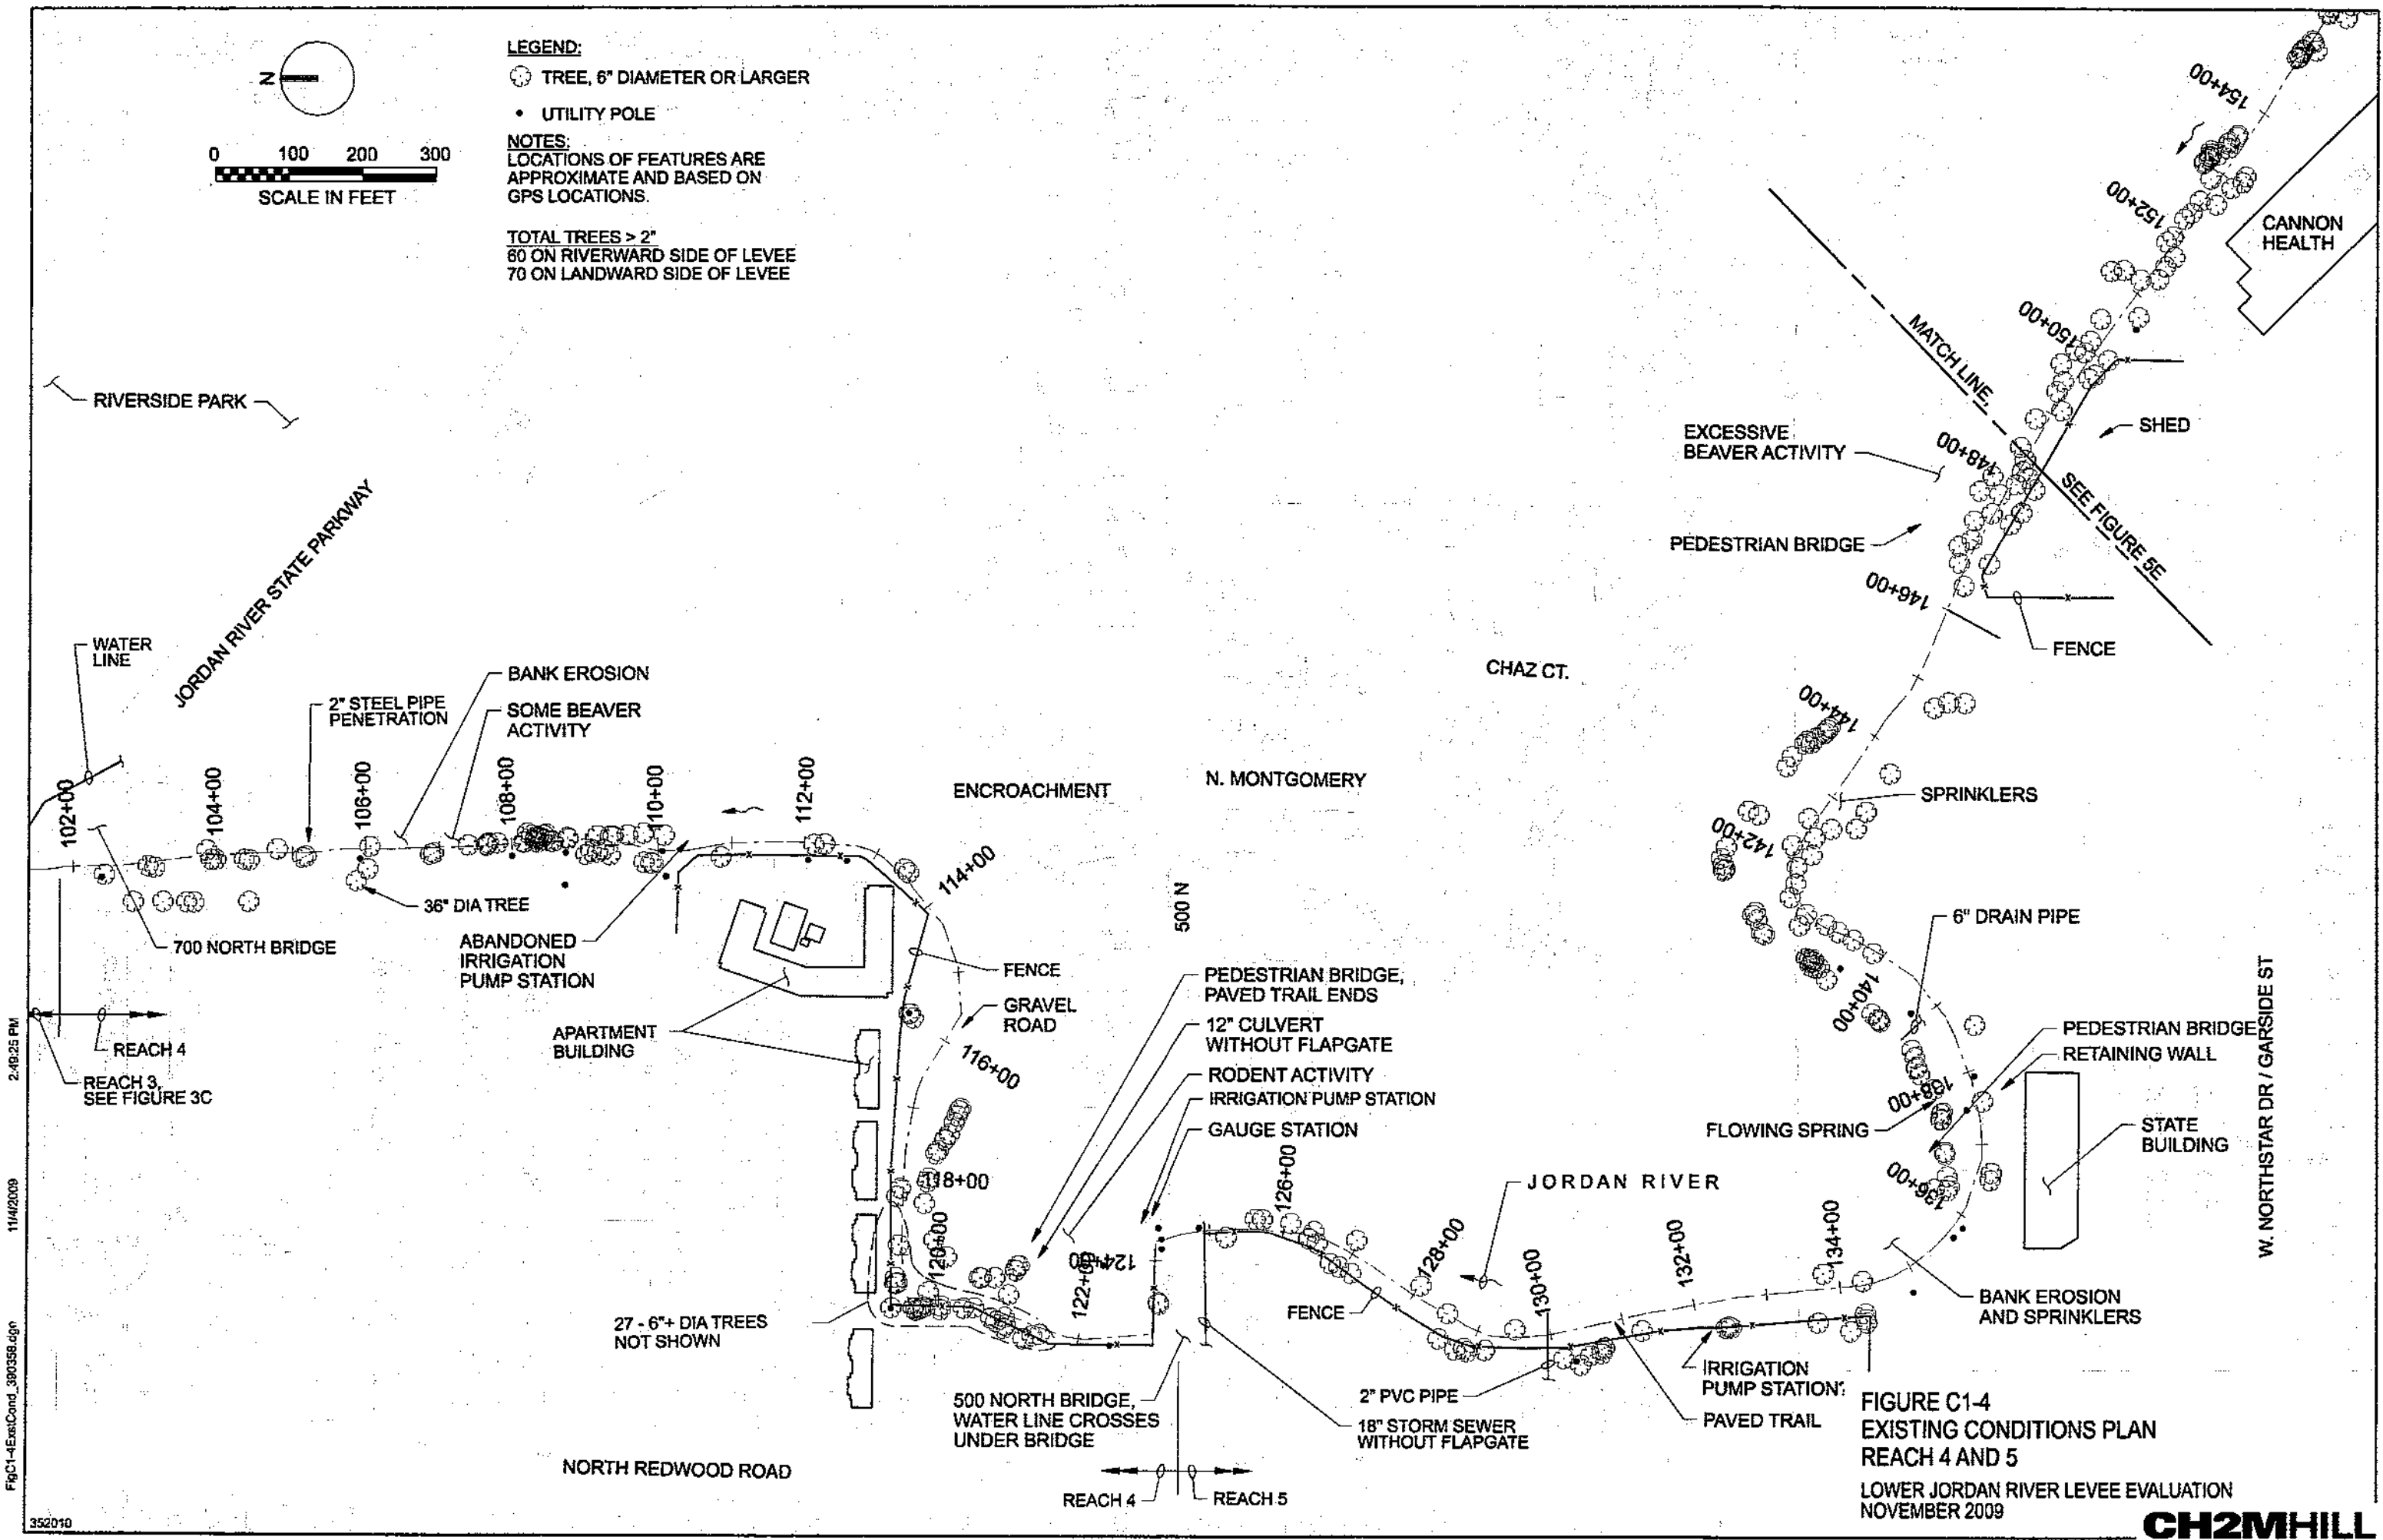
**FIGURE C1-4**  
**EXISTING CONDITIONS PLAN**  
**REACH 4 AND 5**  
 LOWER JORDAN RIVER LEVEE EVALUATION  
 NOVEMBER 2009

**TOTAL TREES > 2"**  
 60 ON RIVERWARD SIDE OF LEVEE  
 70 ON LANDWARD SIDE OF LEVEE

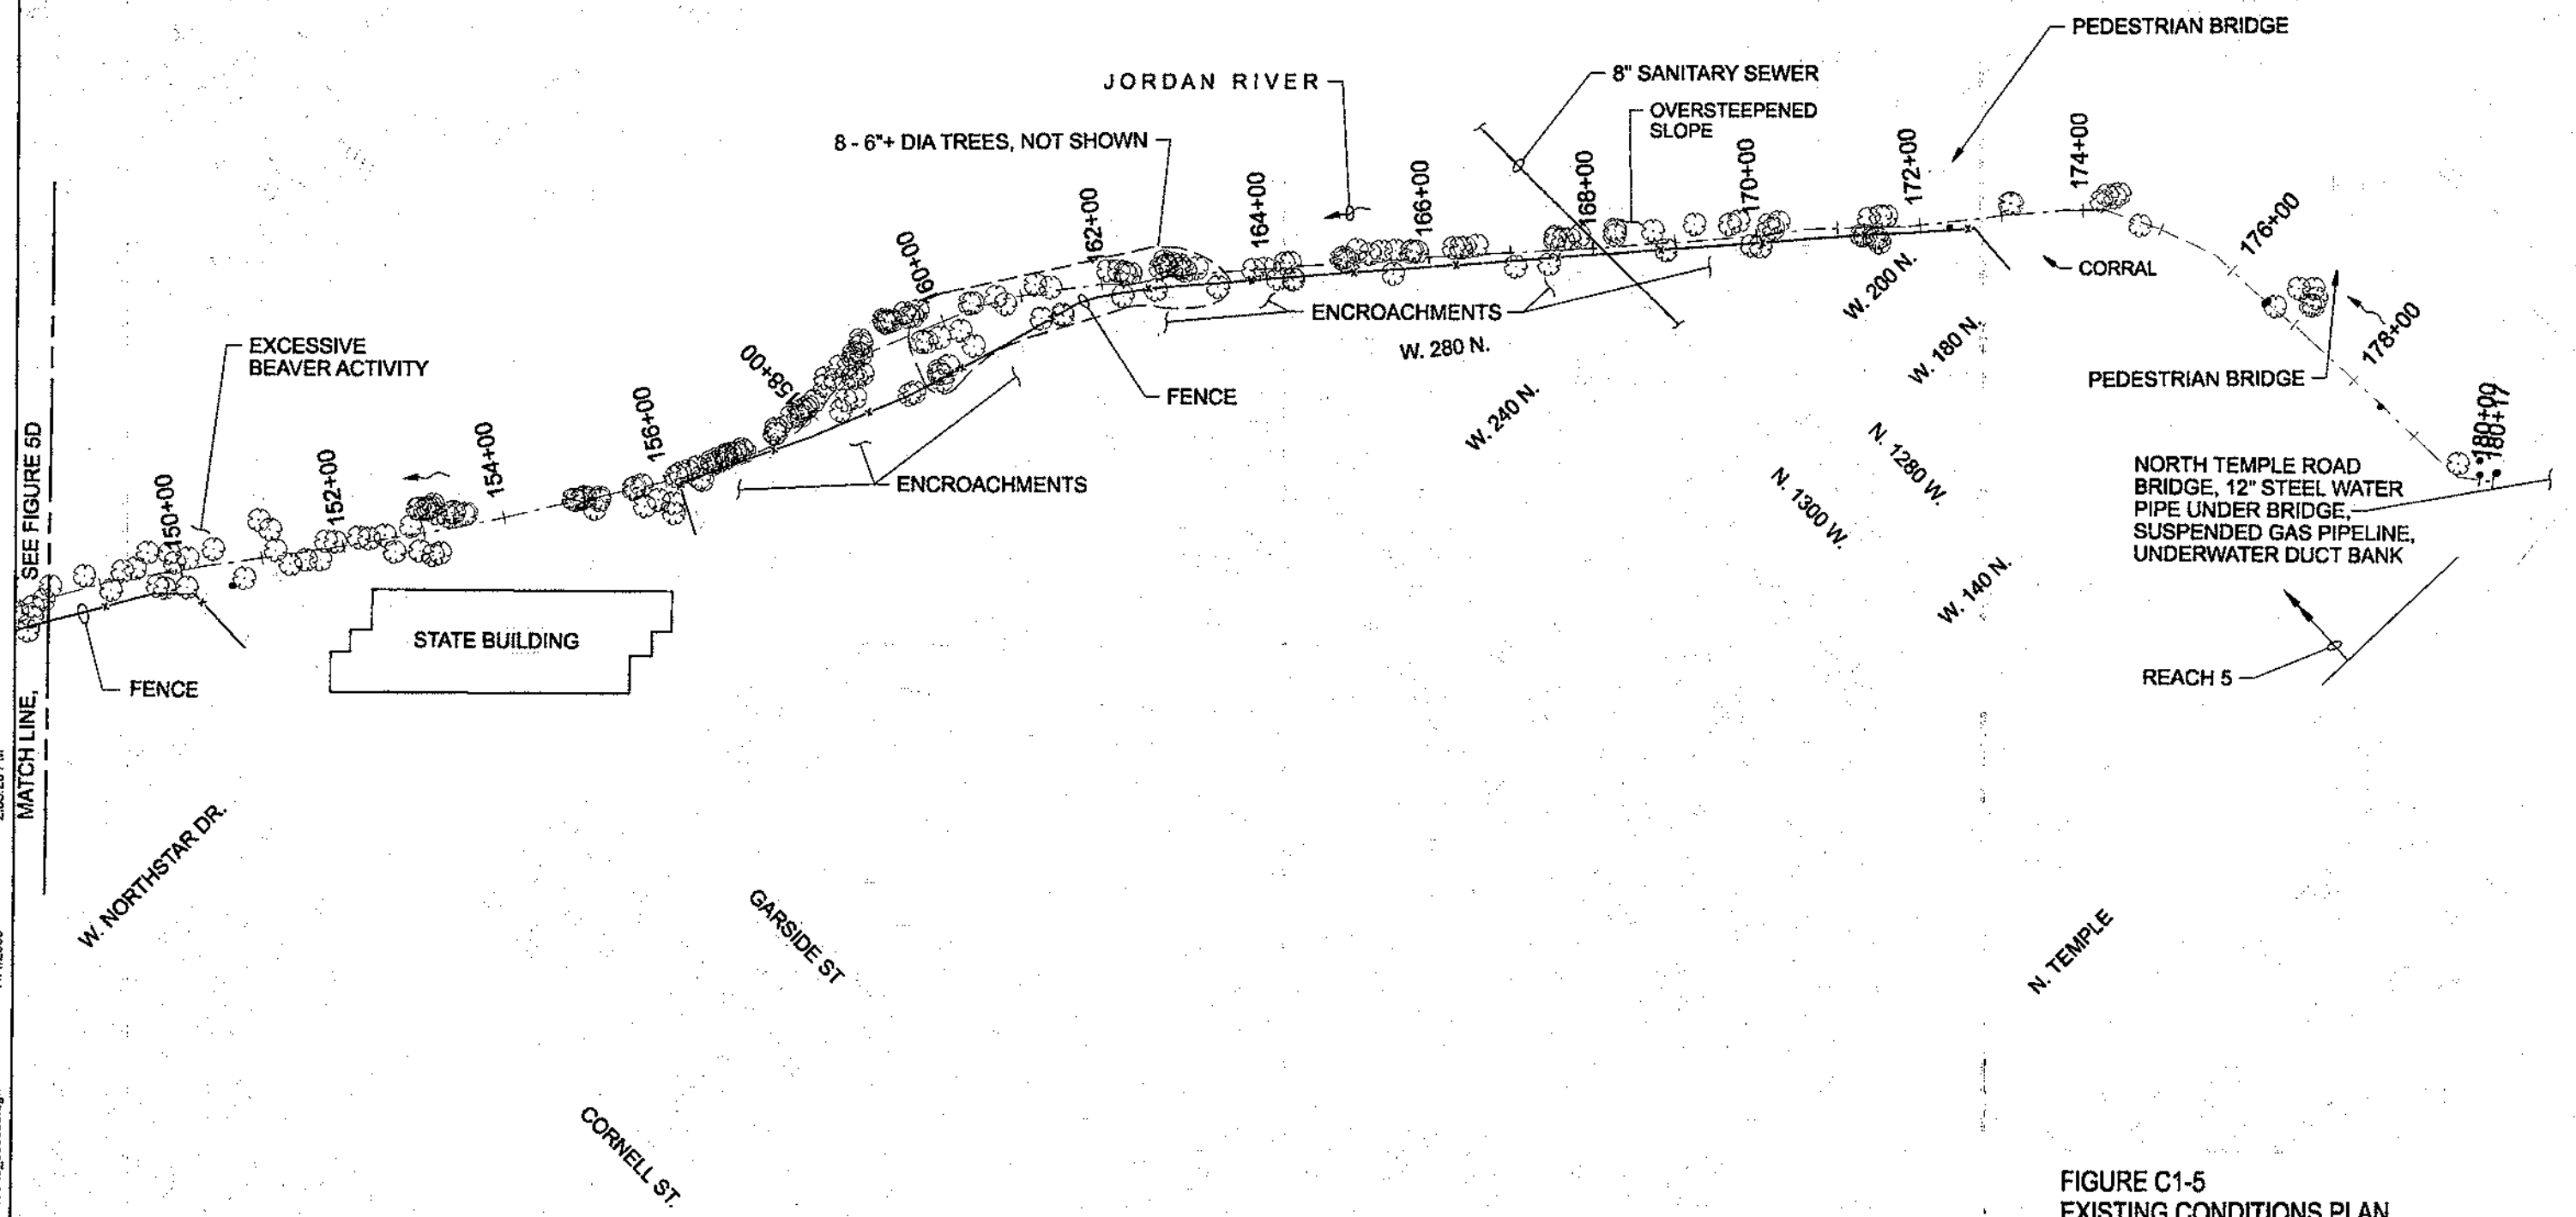
**FIGURE C1-5**  
**EXISTING CONDITIONS PLAN**  
**REACH 5**  
 LOWER JORDAN RIVER LEVEE EVALUATION  
 NOVEMBER 2009

**TOTAL TREES > 2"**  
 220 ON RIVERWARD SIDE OF LEVEE  
 60 ON LANDWARD SIDE OF LEVEE
