the Watershed Watch

Newsletter of Salt Lake County's Watershed Planning & Restoration Program

Spring 2020, Issue 21

We're recycling old Christmas trees to protect and repair eroding stream banks

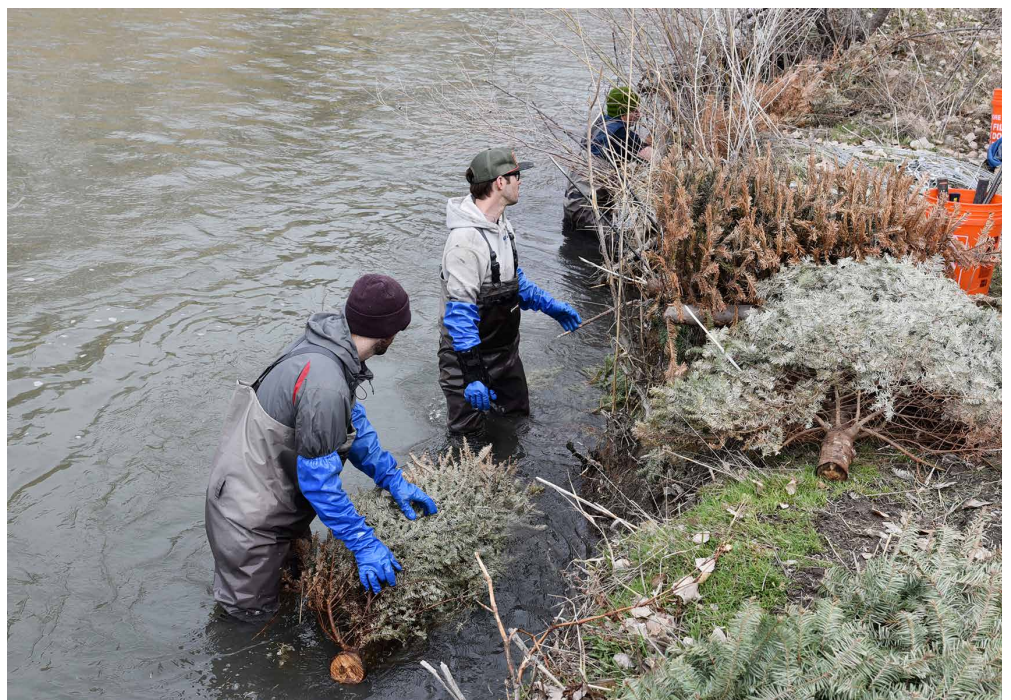
SLCo Watershed uses discarded Christmas trees to repair and protect stream banks that are eroding excessively. These "conifer revetments" are remarkably effective and cost efficient.

Conifer revetments are non-sprouting trees that have been wired together in an overlapping chain, and then secured to the base of an eroding stream bank with metal earth anchors. Old Christmas trees are ideal for use in revetments given their dense branches and ready availability in urban settings. Branches are removed from one side of the trunk to allow for a secure and tight fit against the bank. Installed with the underside of the tree facing upstream, the branches create a “roughness” that catches the current and slows the stream velocity along the bank. This protects the fragile bank from further erosion. The dense branches trap and collect sediments and debris. Eventually, the sediment builds up to form new banks and rebuilds the floodplain, making the river more resilient during flood events. Live willows or other quickly sprouting native riparian plant species can be planted behind the revetment to provide more immediate permanent vegetative cover and rooting stabilization.

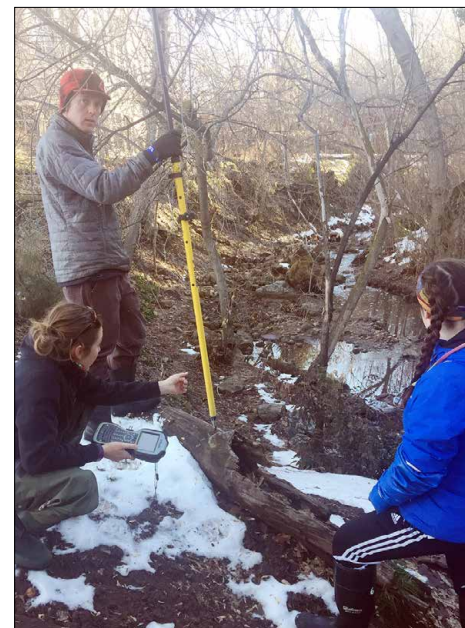
Westminster College students learn river surveying techniques where Emigration Creek flows through campus, home to Salt Lake County's newest stream gauge.

We worked closely with the students for the duration of the semester, visiting various stream gauges and completing Level III surveys which include longitudinal profiles, cross sections, and pebble counts. A longitudinal profile characterizes the average slope of the stream, and the depth and sequence of different stream features including pools, glides, riffles, and runs. These features are defined by water surface elevation, material on the channel floor, and amount of water within the channel.

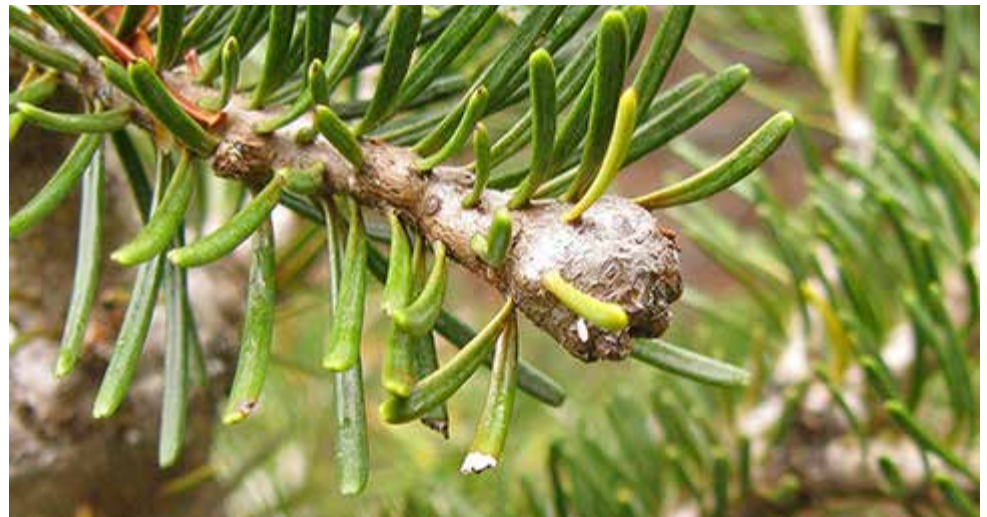
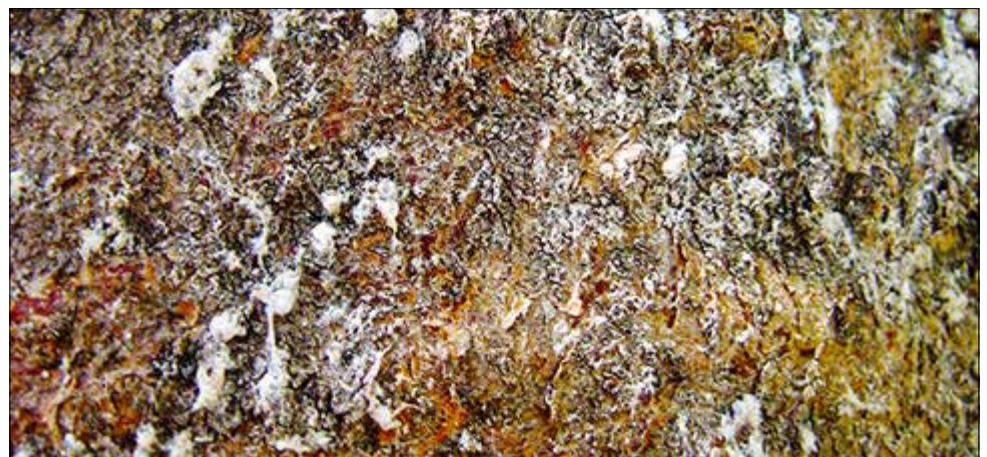
Two common symptoms of a balsam woolly adelgid infestation: (top) Abnormal swelling, or gouting, of fir branches caused by feeding injury; (bottom) white woolly insect masses on a tree trunk. (Photos: US Forest Service)

- yellowing needles on inner branches
- lower crown dieback leaving a green top
- abnormal swelling of branch nodes, called gouting
- woolly material on tree bole (trunk)
- reduced cone production
- dead leaders

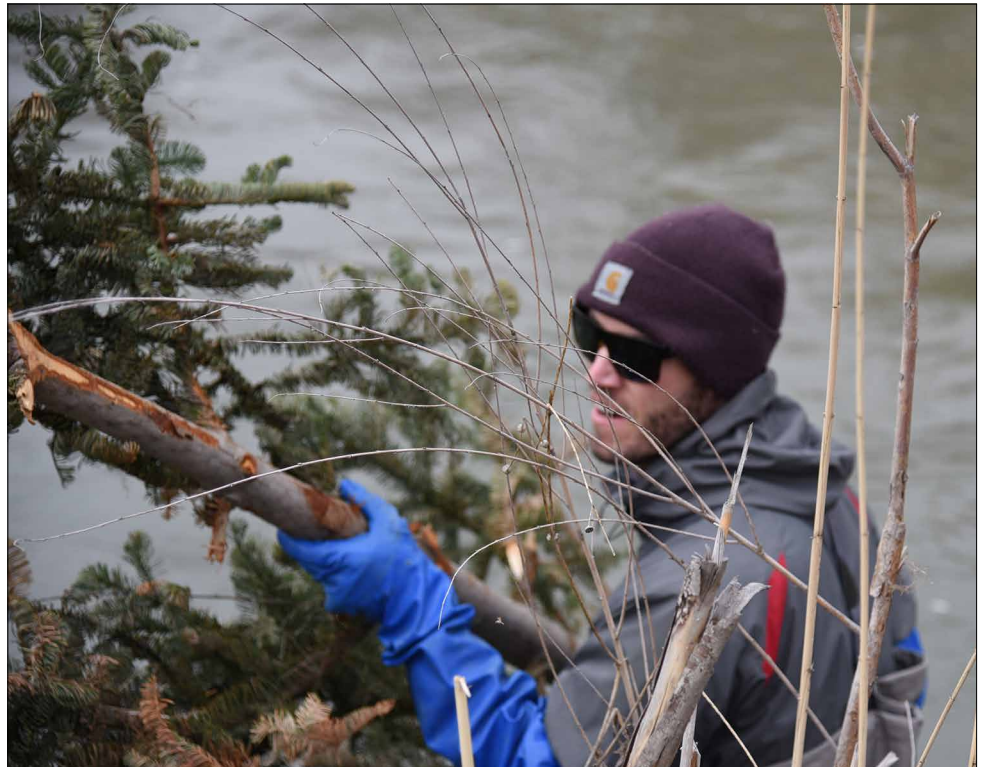
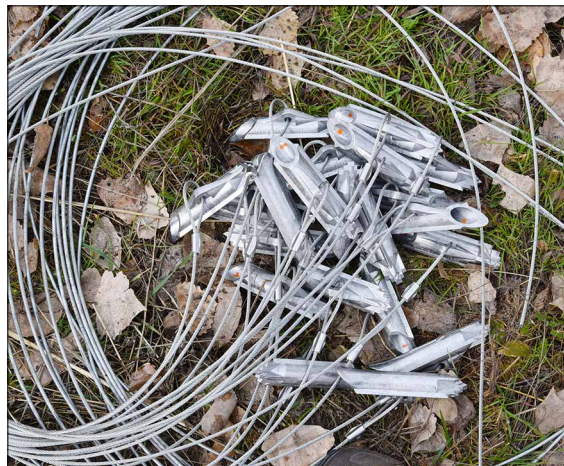
Discarded Christmas trees are collected from the landfill and prepped for installation along stream banks. Wired together in a chain and secured to the bank with metal earth anchors (left), the tree branches create a “roughness” that helps to slow down the water current at the bank. This protects eroding stream banks. Over time the branches collect and hold sediment, providing fertile ground for new riparian plants. The deep roots of native riparian plants stabilize the bank and increase wildlife habitat.
