**VOLUME 3 - APPENDICES**  
**JORDAN RIVER**  
**HYDRAULIC STUDY**

July 2019

**BOWEN COLLINS**  
& ASSOCIATES

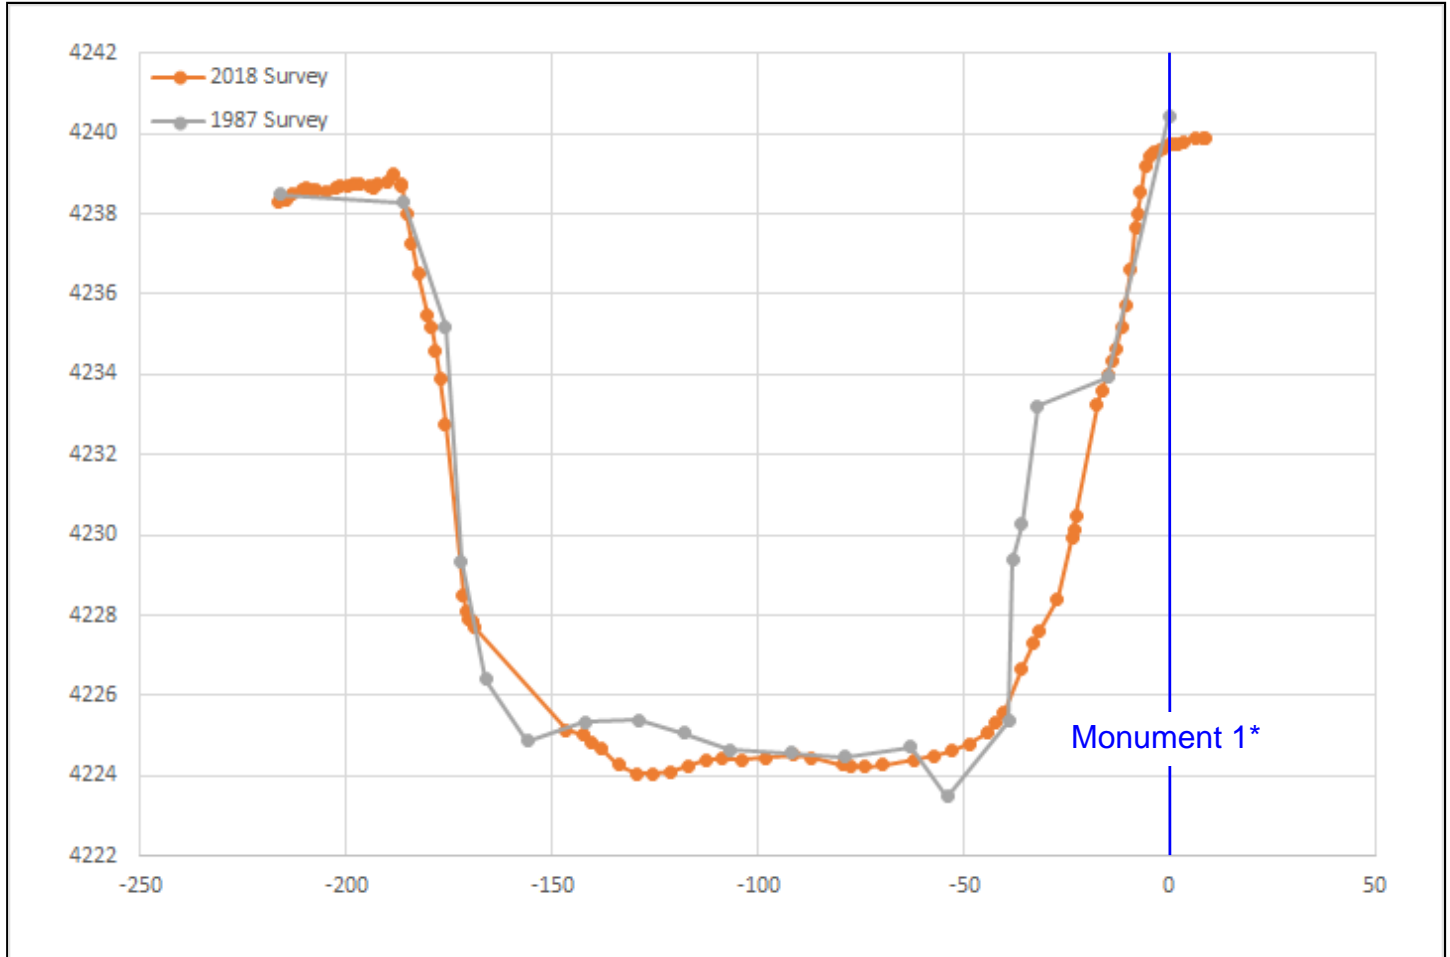
## Monumented Cross Sections Monument 1\* (2100 South)

1. Minimal changes.

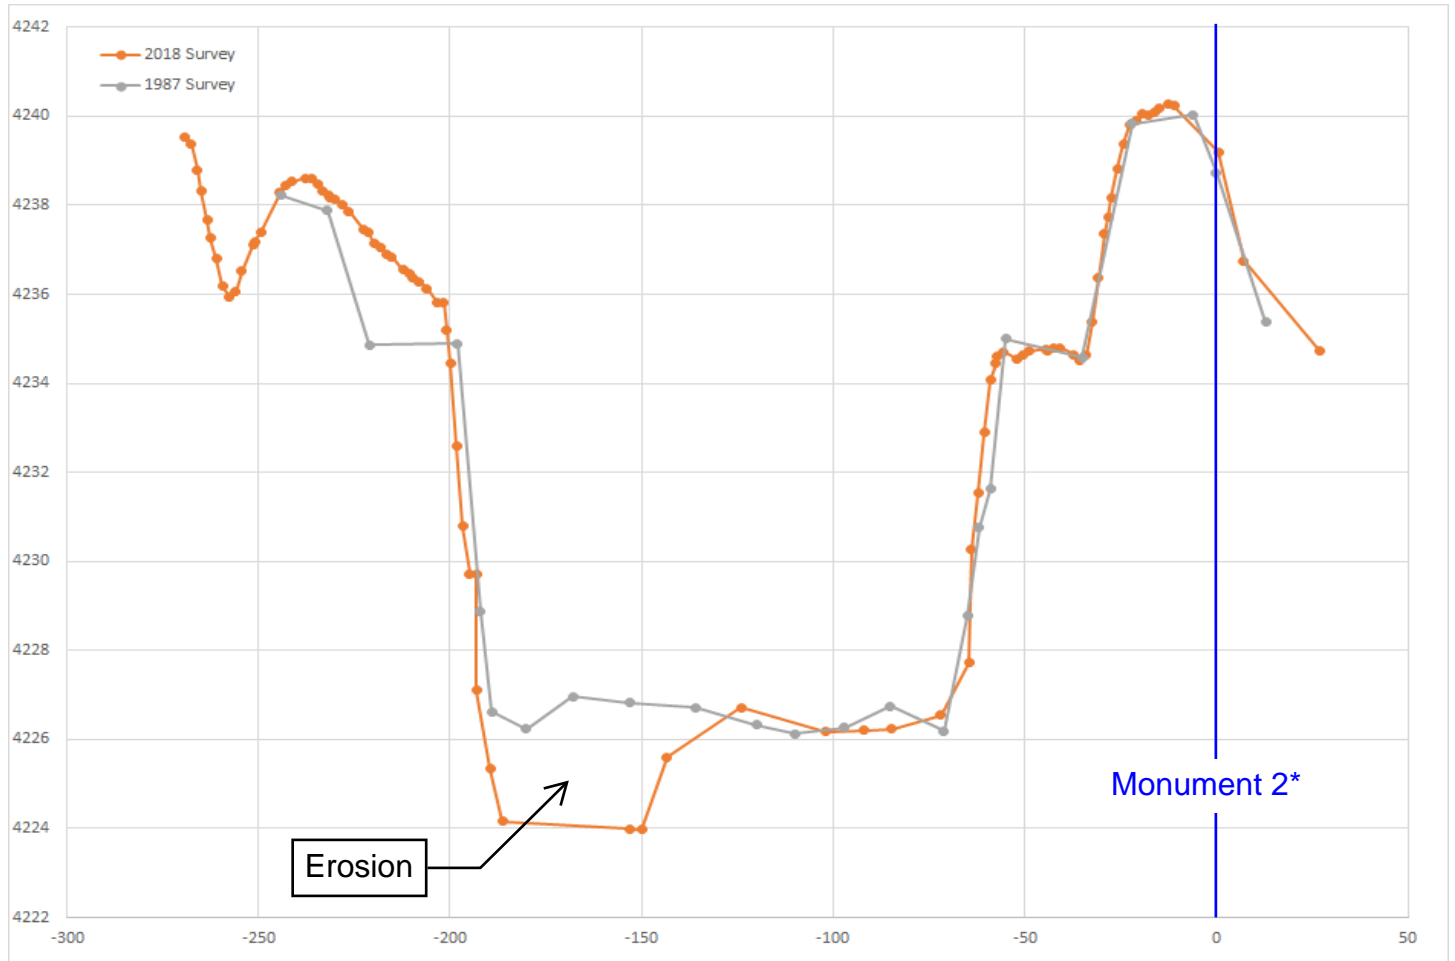
## Monumented Cross Sections Monument 2\* (2600 South)

1. Channel bottom has experienced erosion or dredging of approximately 2 feet.
2. Other changes are minimal.

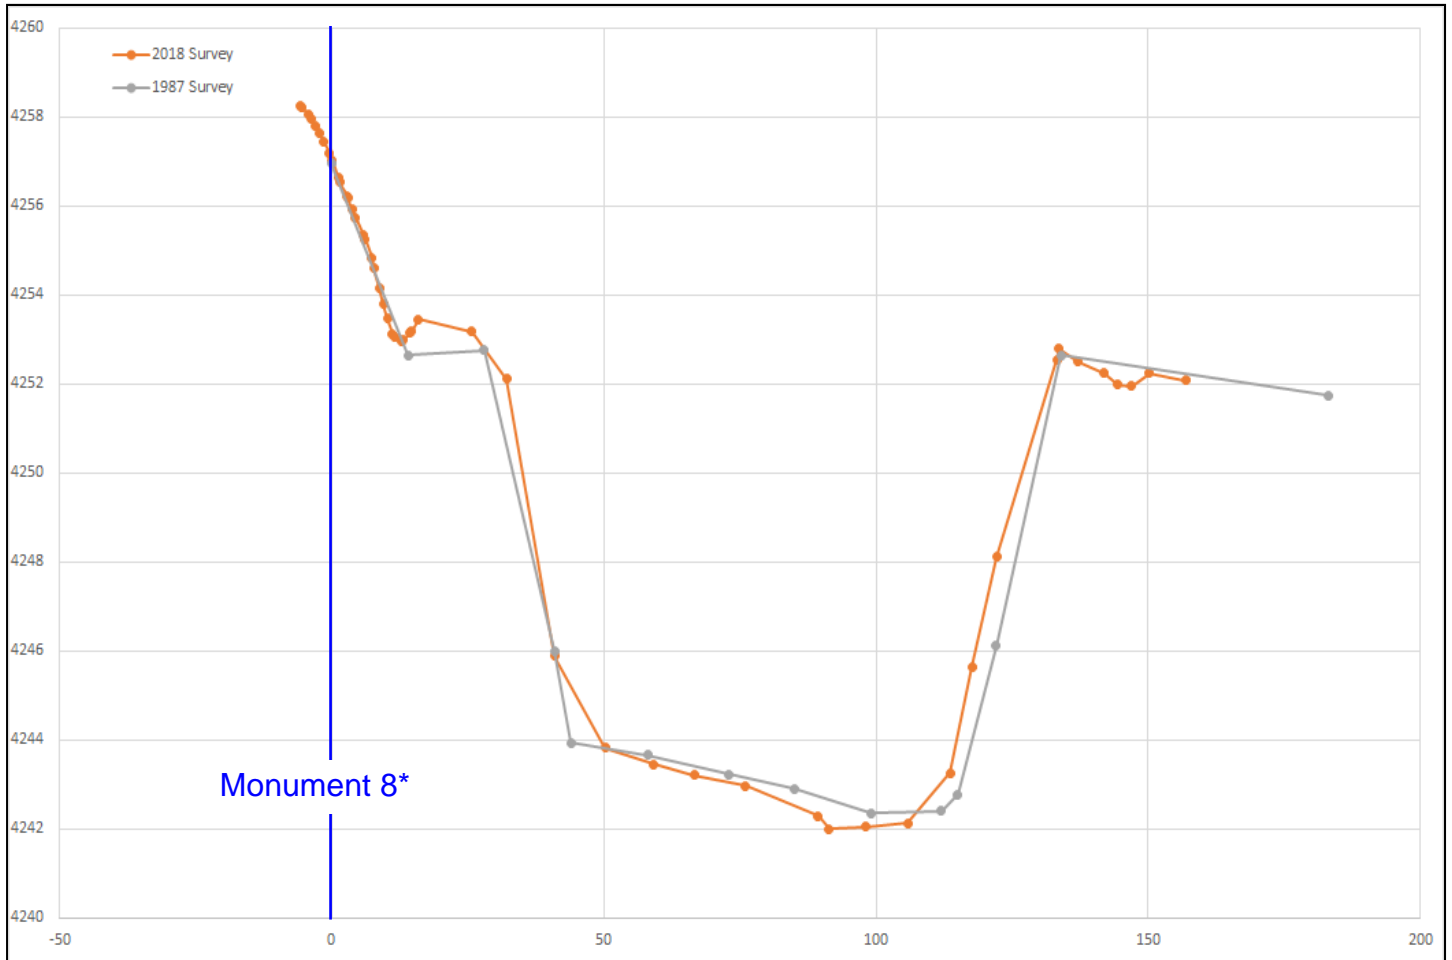
## Monumented Cross Sections Monument 8\* (4700 South)

1. Minimal changes.

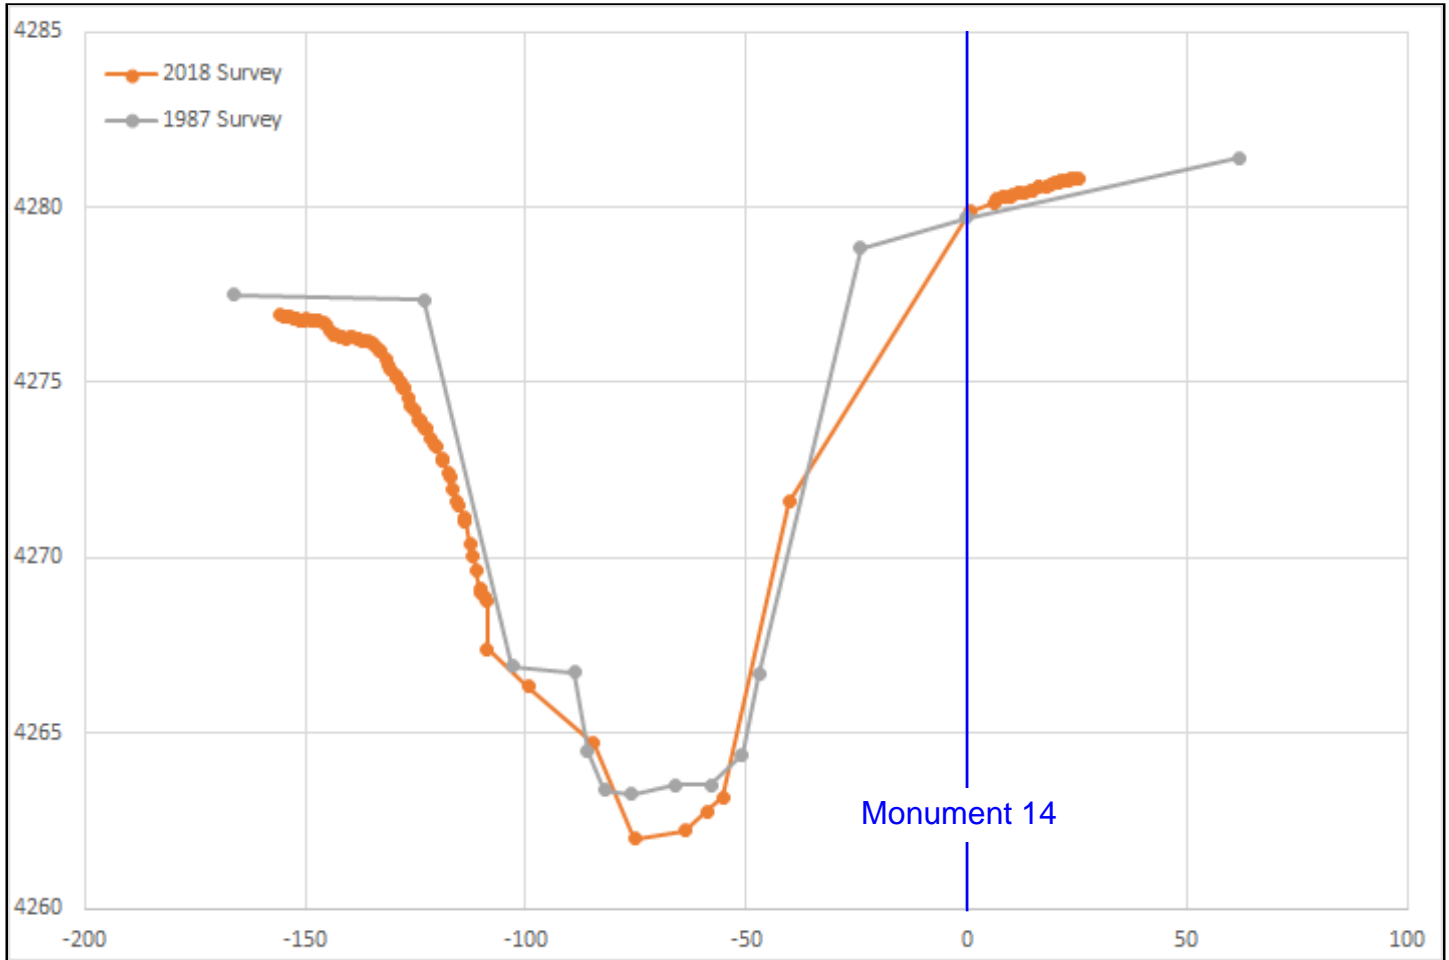
## Monumented Cross Sections Monument 14 (6400 South)

1. Banks have been laid back slightly.
2. Channel bottom is approximately 1 foot deeper due to erosion.

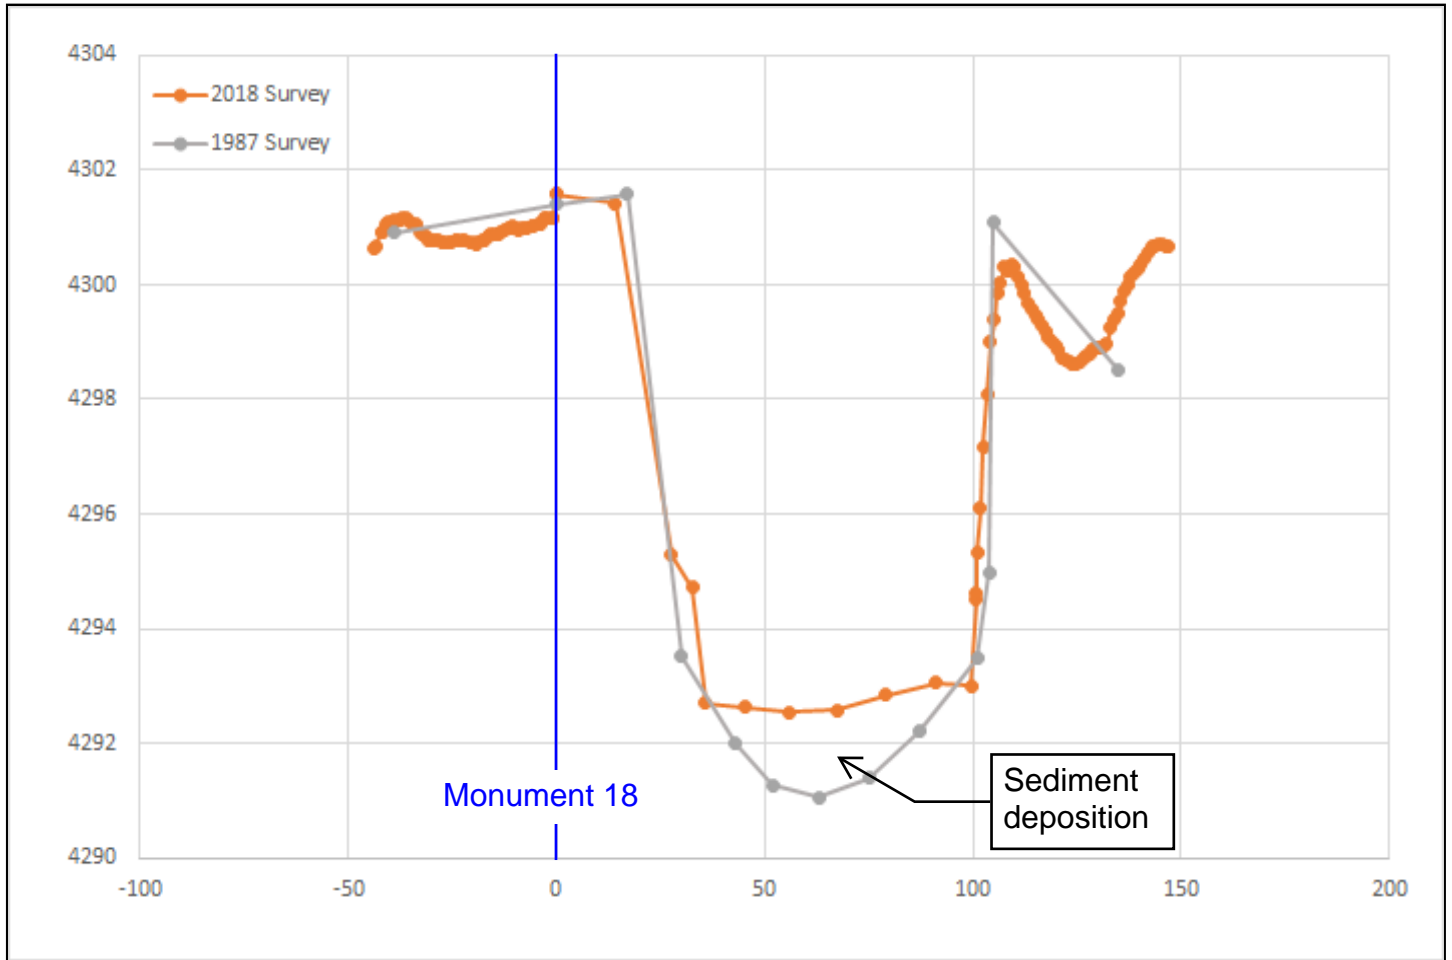
## Monumented Cross Sections Monument 18 (8900 South)

1. Approximately 1.5 feet of sedimentation in the channel bottom.
2. Other changes are minimal.

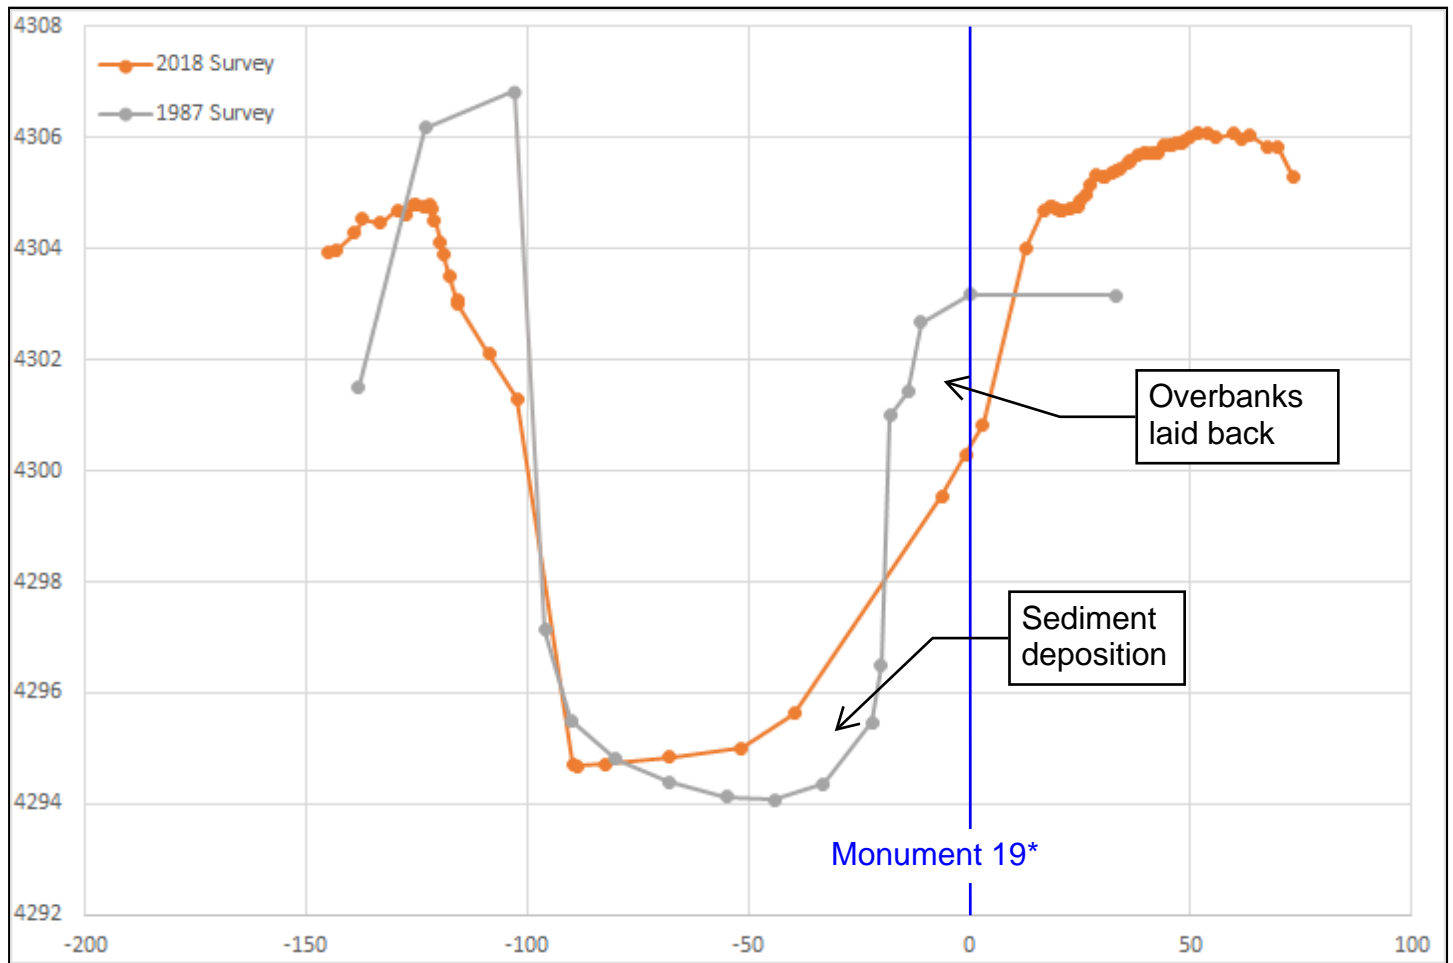
## Monumented Cross Sections Monument 19\* (9300 South)

1. Approximately 1 foot of sediment deposition in the channel bottom.
2. Overbanks are laid back.

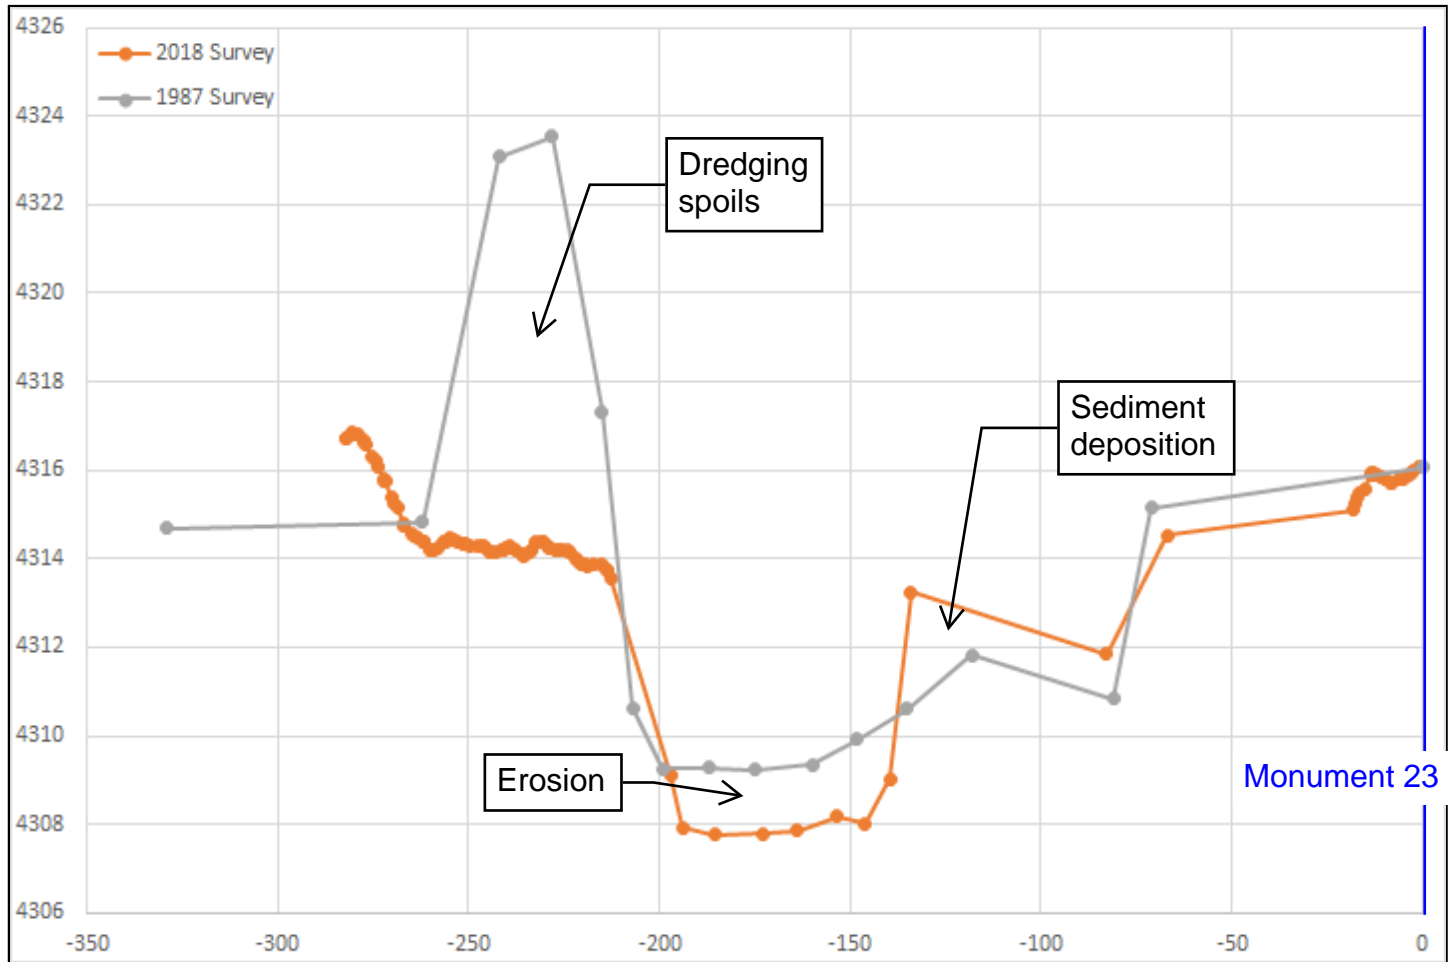
## Monumented Cross Sections Monument 23 (10700 South)

1. Channel bottom has experienced erosion approximately 1.5 feet deep.
2. Dredging spoils from 1985 dredging have been removed.

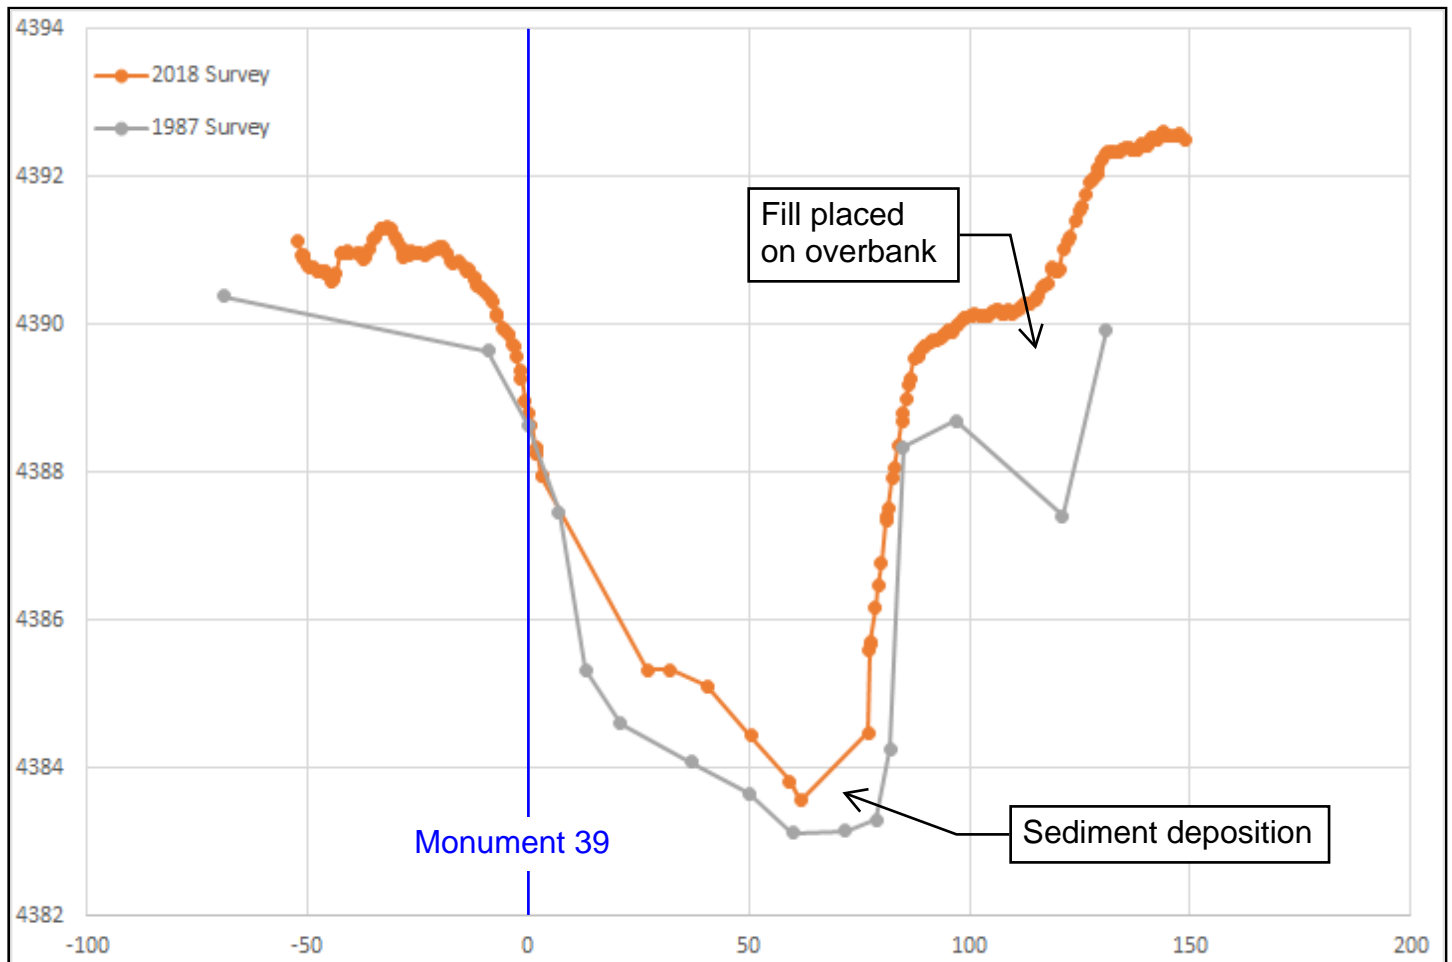
## Monumented Cross Sections Monument 39 (14700 South)

1. Approximately 1 foot of sedimentation in channel.
2. Fill has been placed on overbanks.

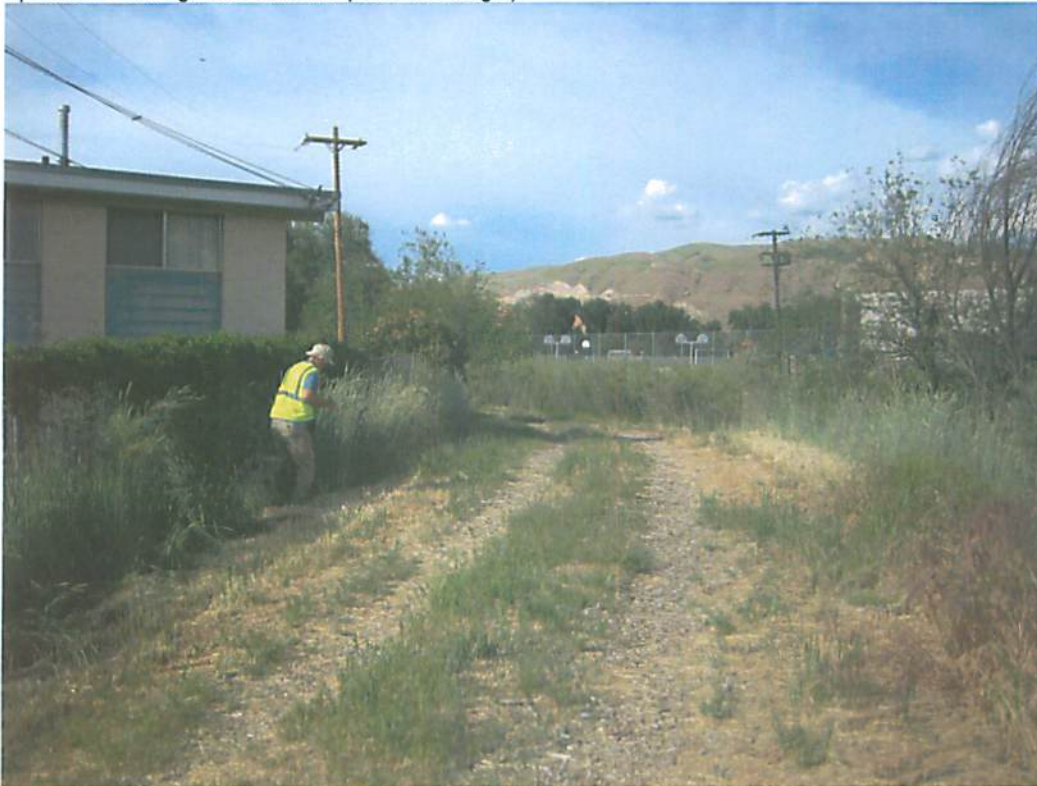
**PHOTO 13**

- The levee was well defined in this reach. The northern part of this reach had a relatively wide right-of-way landward of the levee that was open space. There was a severe encroachment by an apartment building mid-point along the reach (see Photo 13).

Apartment Building Encroachment (river on the right)

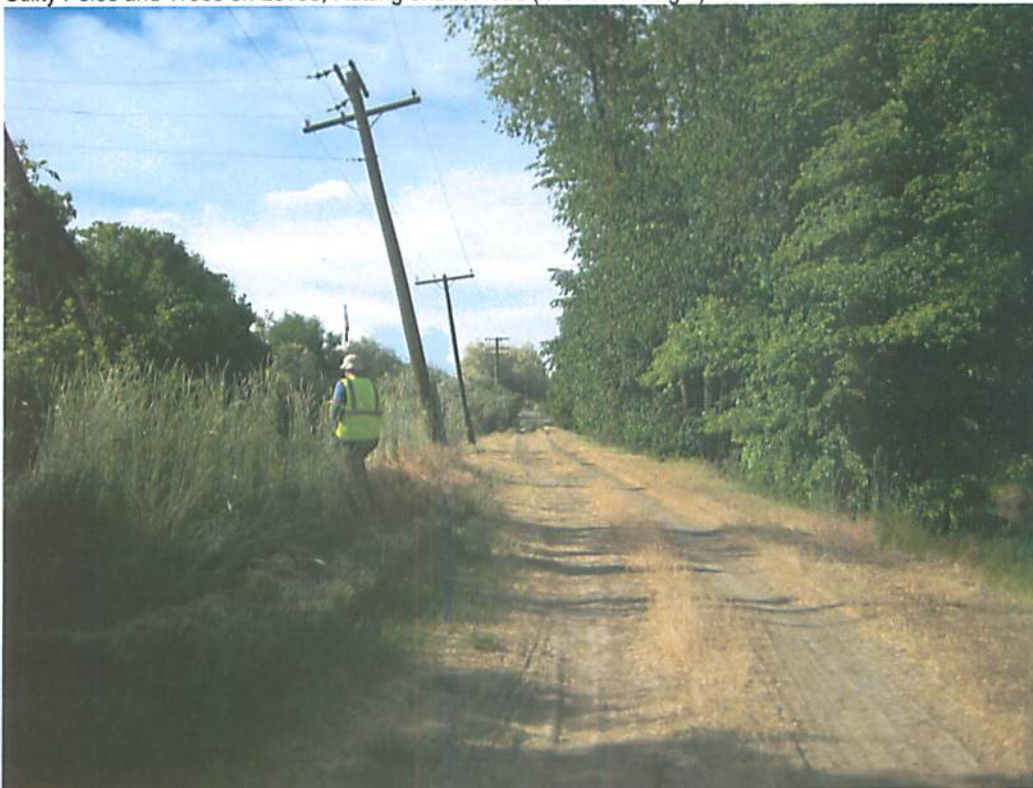
PHOTO 17

Utility Poles and Trees on Levee, Rutting of Dirt Road (river on the right)

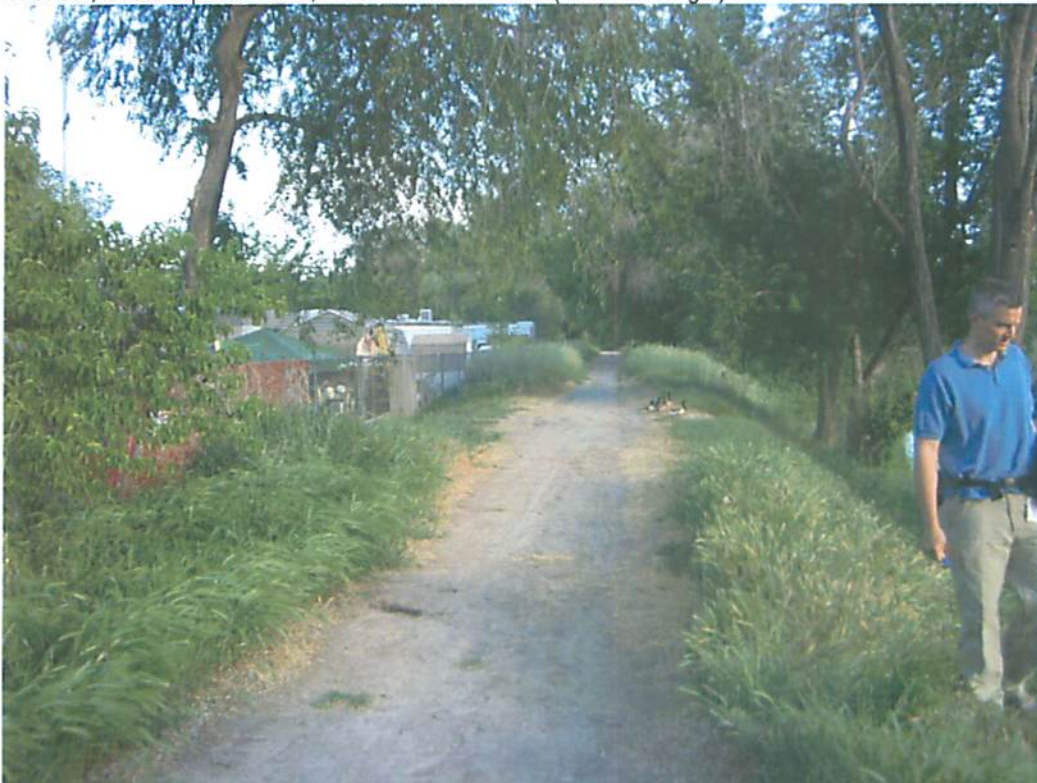
**PHOTO 21**  
Dirt Path, Oversteepened Bank, Trees in Levee Section (river on the right)

- The riverward side of the southern area was oversteepened with sloughing and erosion observed (see Photo 21). Rutting was observed in the crest of the levee.

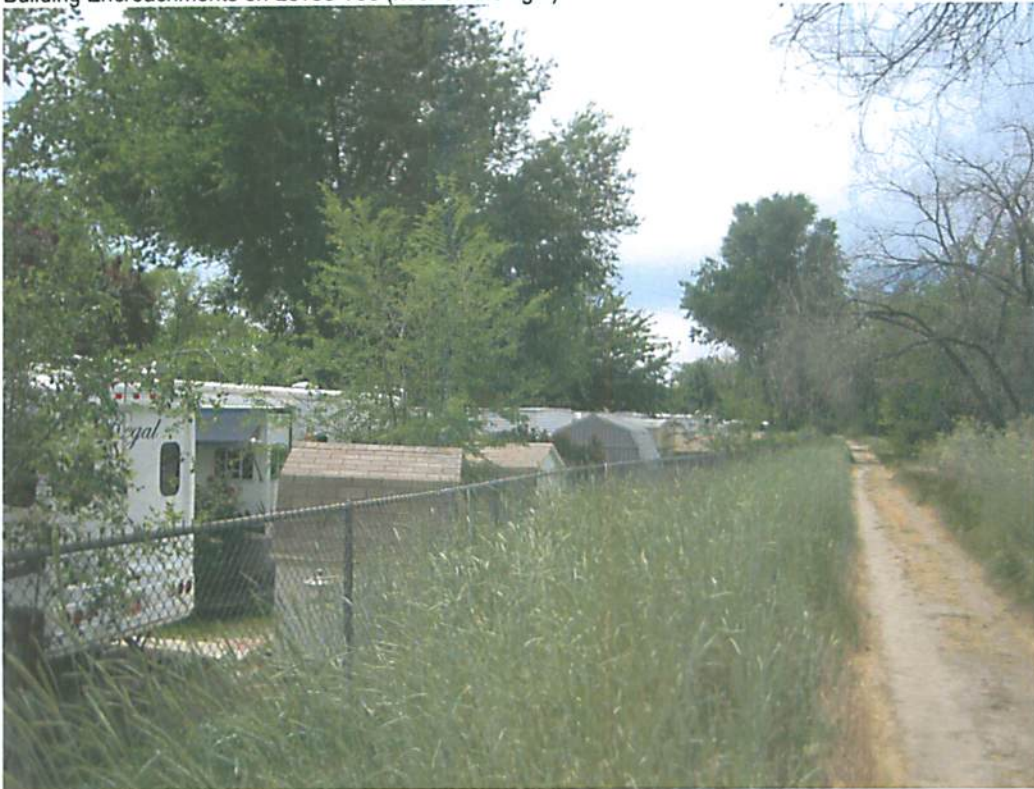
**PHOTO 22**  
Building Encroachments on Levee Toe (river on the right)

- Numerous encroachments were observed. Fencing and some private structures were located on the landward side of the levee in the northern area. One irrigation pump station was identified (confirm if abandoned), park irrigation piping, and one apparent well with 2-inch PVC discharge to the river was observed in the northern area (confirm ownership of this piping). Various utilities, landscaping retaining walls, sprinklers, and a parking lot were located in the middle area. A trailer park directly abuts the levee in the south area. Numerous storage sheds (26), fixed mobile homes (2 to 3), and numerous recreational vehicles directly abut a fence located on the levee (see Photo 22). A small corral and three large utility poles are located on the levee directly across the river from the fairgrounds. This area across from the fairgrounds is a paved parking lot.

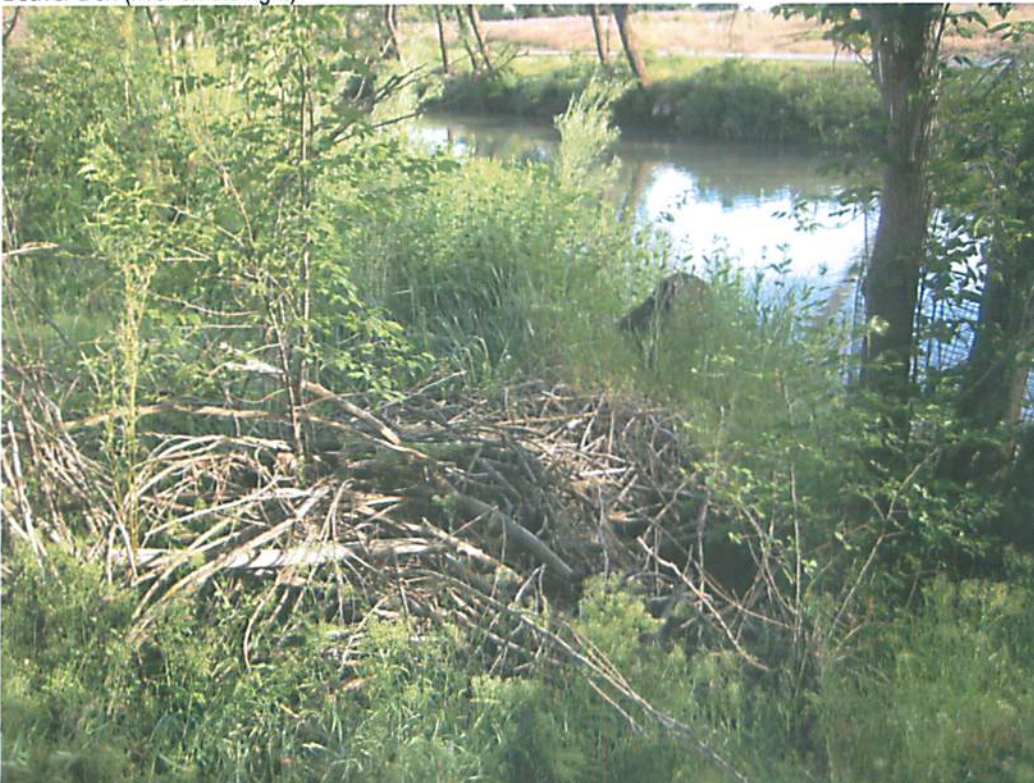
**PHOTO 23**  
Beaver Den (river on the right)

- Beaver activity was observed (see Photo 23). Several pronounced collapsed dens were observed in the middle area of the reach. Some small rodent activity was observed in the southern area.

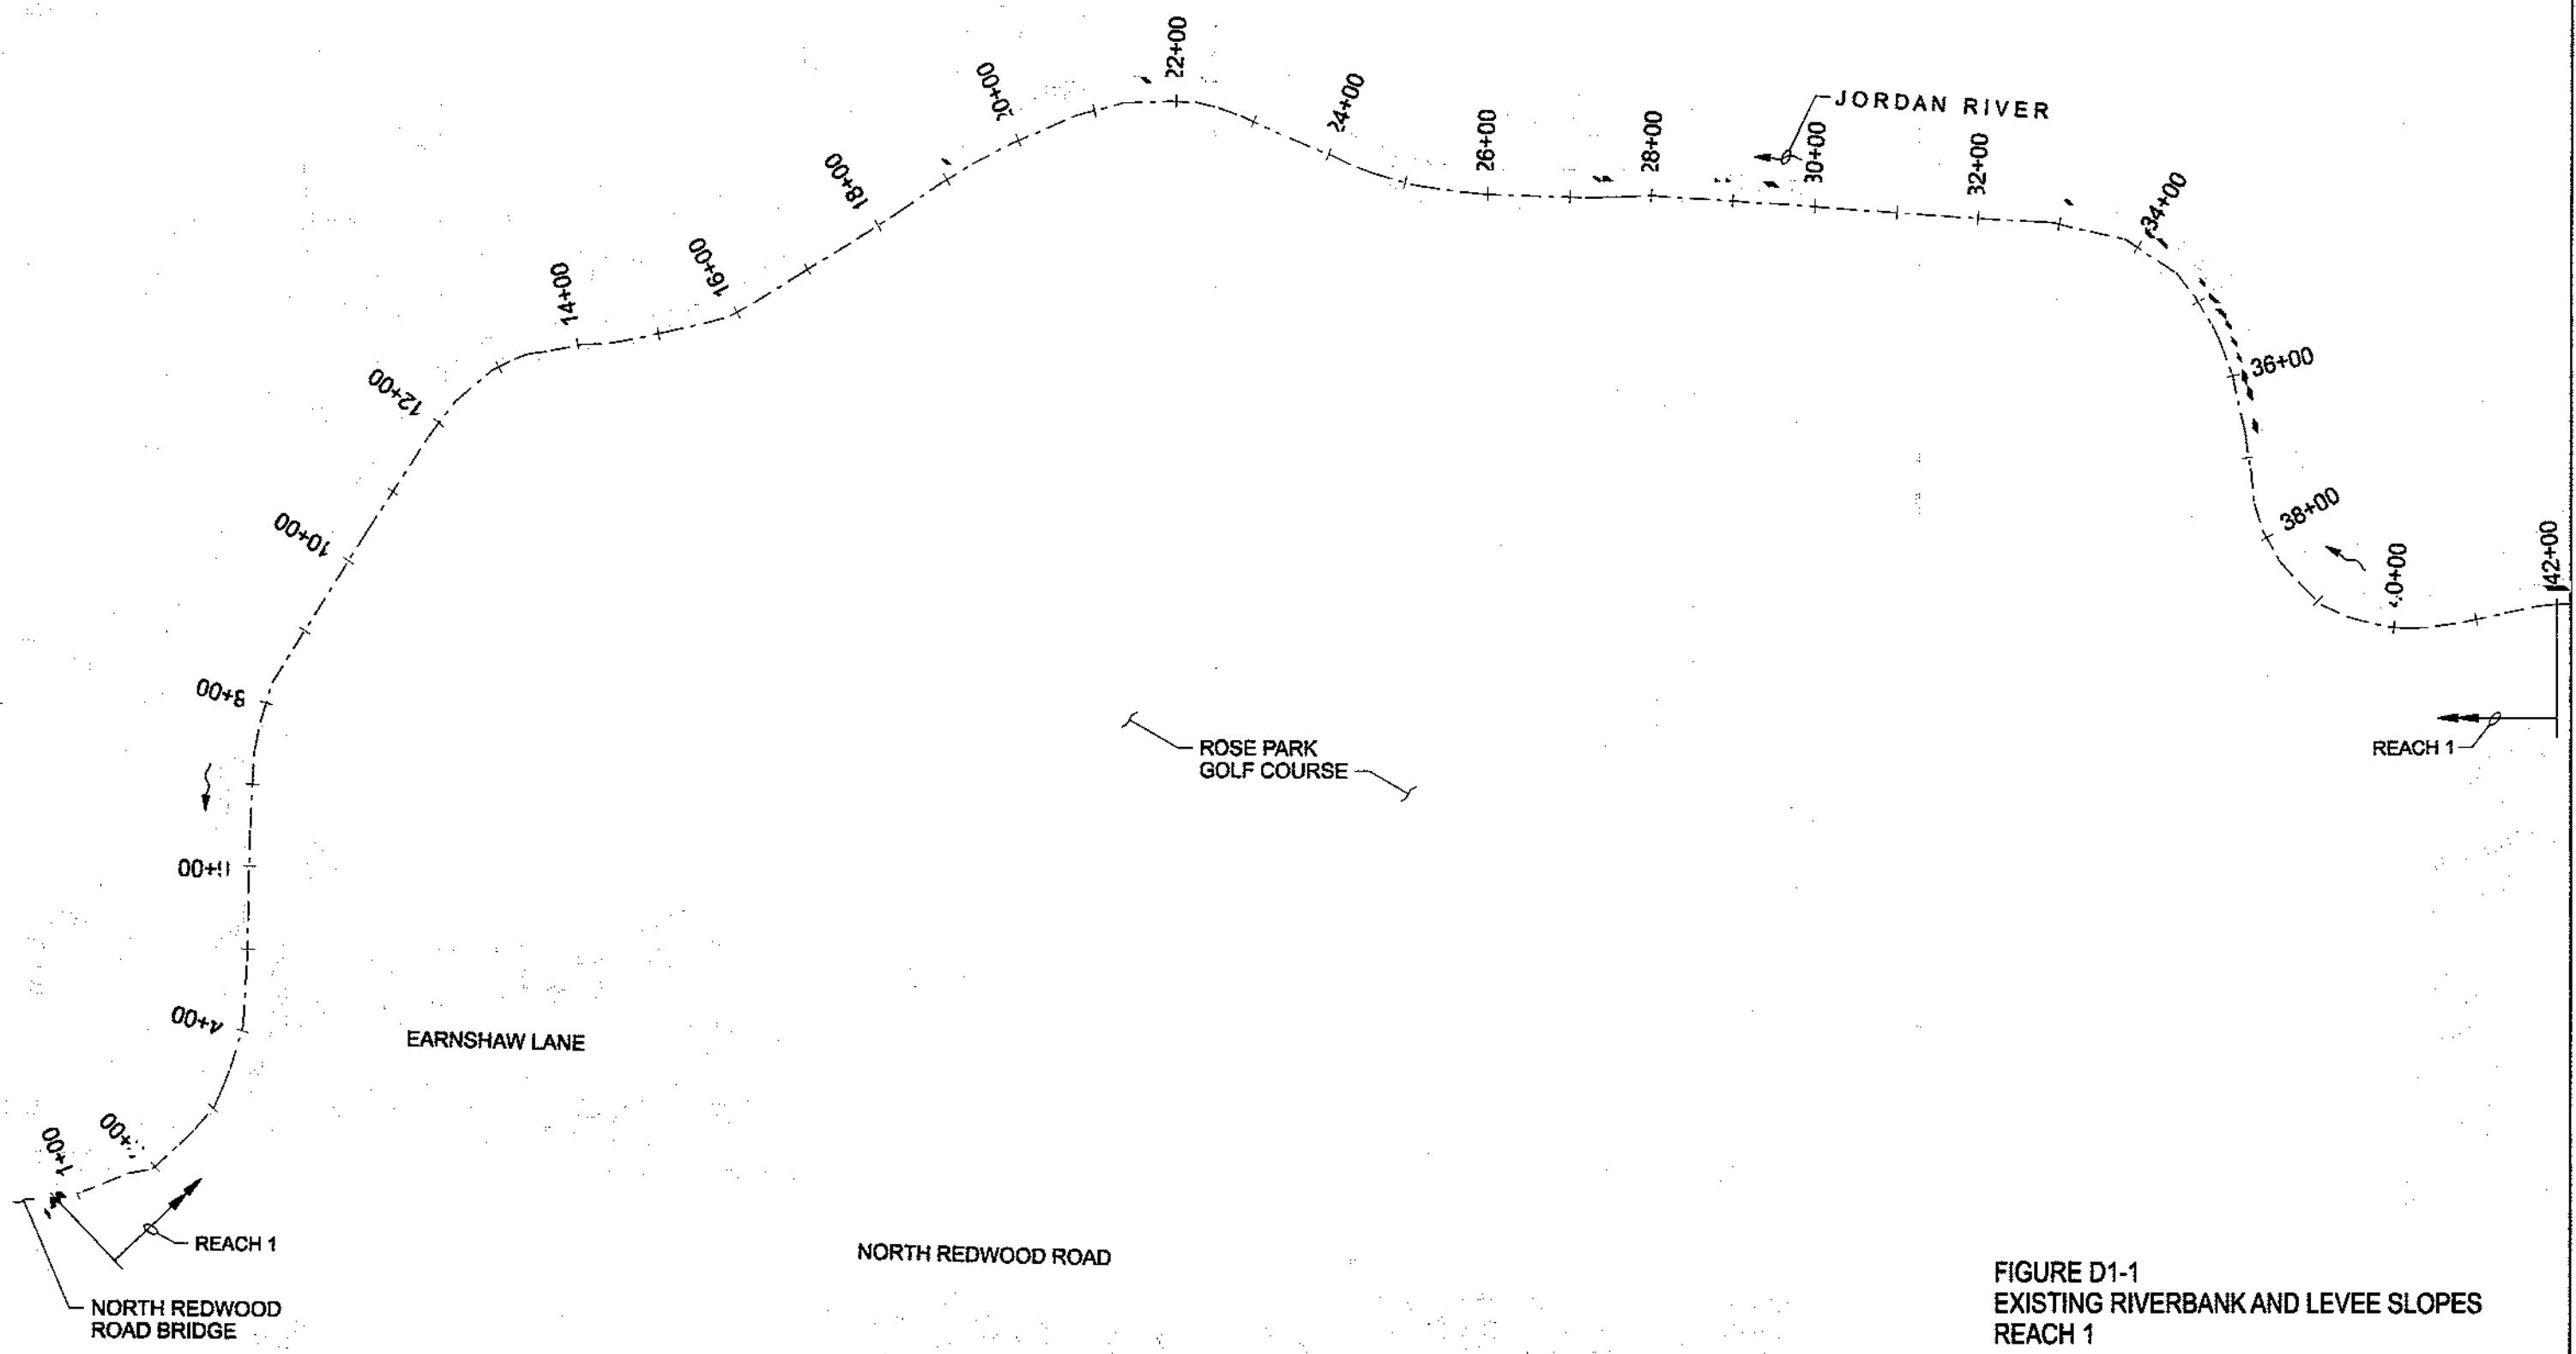
**FIGURE D1-1**  
**EXISTING RIVERBANK AND LEVEE SLOPES**  
**REACH 1**  
 LOWER JORDAN RIVER LEVEE EVALUATION  
 NOVEMBER 2009  
**CH2MHILL**

3. Significant lengths of the levee were excessively steep with side slopes on the riverward side in excess of 1:1. These reaches were commonly found immediately adjacent to the river channel. Surface cracking along the crest of the levee and sloughing of the levee/river bank were commonly observed. While not an immediate structural threat to the levee, it is indicative of a long-term trend of bank erosion and potential channel migration. These oversteepened banks could also pose a serious threat to levee integrity during a flood event.
