VOLUME 1 - REPORT

SOUTHWEST CANAL AND CREEK STUDY

March 2020

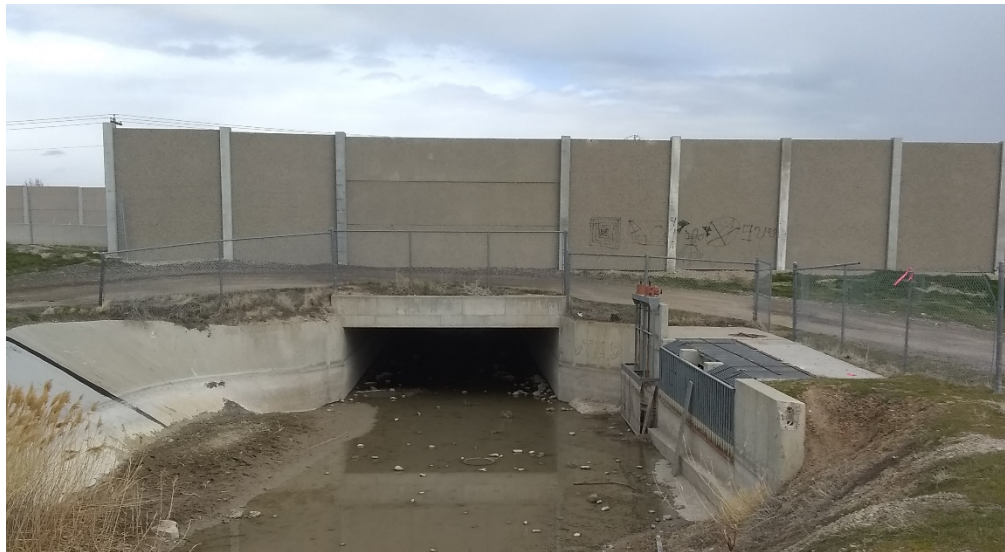
There are three storm water overflow/dump-out structures that discharge from canals to Rose Creek. The overflow structures include a gate to drain the canal, and a weir to overflow into the storm drain system, as shown on Photo 2-1. Table 2-1 identifies the locations of the 3 existing storm drain overflow/dump-out structures.

***Photo 2-1
Overflow/Dump-Out Structure at Utah and Salt Lake Canal***

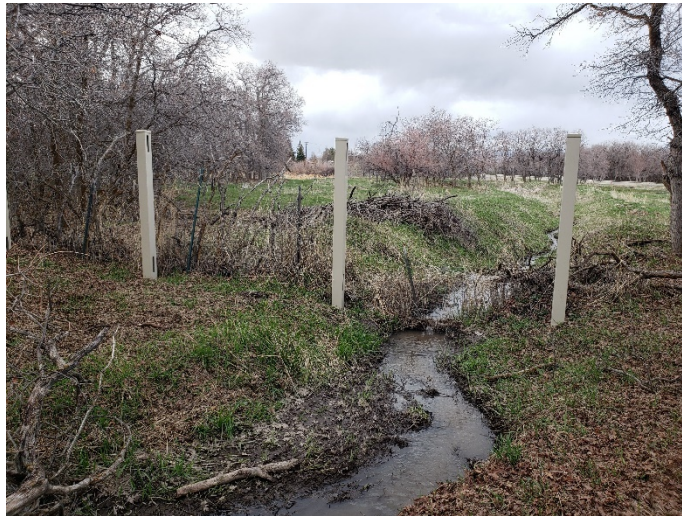
There are several locations where fences cross the Rose Creek Channel. During a large flood it is likely that debris would collect on the fences and restrict flow through the channel. Some of the locations of those fence crossings are identified in Appendix A.

*Photo 2-2
Fence Crossing Rose Creek Upstream of Spring Canyon Drive*

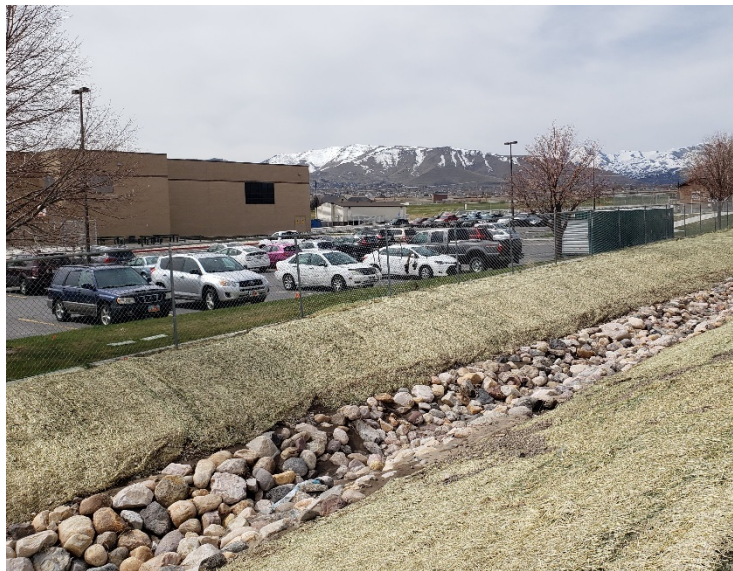
There are locations where there are constructed earthen levees along Rose Creek that probably cannot be certified to meet minimum FEMA design criteria due to a lack of freeboard. If FEMA updates the Flood Insurance Rates Maps (FIRMs) upstream of the Utah Lake Distribution Canal, the floodplains adjacent to uncertified levees may be mapped as if the existing earthen levees do not exist, even if the existing channel has adequate capacity. The locations of the uncertified levees are identified below:

- Upstream of 4000 West adjacent to the South Hills Middle School
- Between 13400 South and 3600 West adjacent to the Riverton Walmart

***Photo 2-3
Uncertified Levee upstream of 4000 West
adjacent to the South Hills Middle School***

5. Earthen levees have been constructed at the tops of the creek banks in two areas: Near the Riverton Walmart and South Hills Middle School. It is recommended that County personnel coordinate with associated City representatives and private property owners to discuss the flood insurance impacts of levees that do not meet FEMA accreditation criteria and to develop a plan to address any needed improvements or to implement an accreditation program.

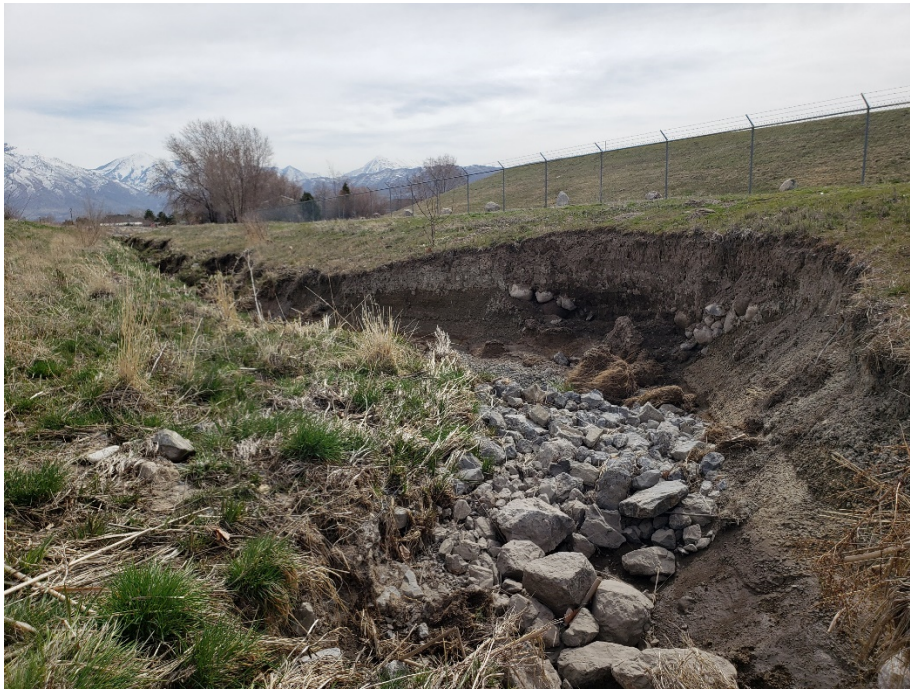
The banks of Rose Creek in some areas have experienced erosion and the bank slope is nearly vertical. However, the vertical banks and the associated bank instability in those areas are not currently adjacent to urban development. An example of the erosion with a near vertical bank is at approximately 3250 West on Rose Creek near the Riverton City Fishing Pond.

Photo 2-4
Eroded Banks on Rose Creek at approximately 3250 West

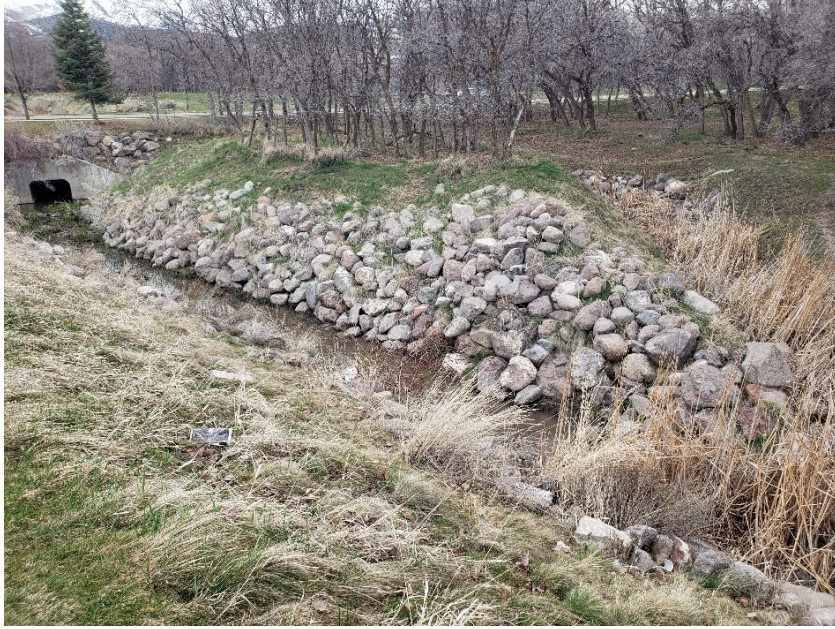
There are several stream segments on Rose Creek where rounded riprap has been installed to armor the banks of Rose Creek. Riprap channel armoring should be angular so that it can better lock together to provide the required erosion protection. The rounded riprap is likely to fail during a major runoff event.

Photo 2-5
Rounded riprap upstream of Spring Canyon Drive (6090 West)

1. Monitor areas where the creek channel has been armored with rounded rock riprap. Rounded riprap has a high potential to fail as it can easily be pushed downstream by the velocity of flowing water. If the armoring fails, those areas should be repaired as needed. It was assumed that those repairs would be funded by private property owners adjacent to the creek.
2. It is recommended that Salt Lake County consider charging a fee for Flood Control Permits for projects that include the installation of riprap and significant channel improvements. The fee should be used to pay for more County oversight during construction. This should allow more quality control and reduce the potential for rounded or undersized riprap from being installed that could fail during a significant runoff event.
